**Urgent Field Safety Notice - Cover letter for
EMBLEM™ Subcutaneous Implantable Cardioverter Defibrillators (S-ICDs)
(Models A209 and A219)
EMBLEM™ S-ICD Subcutaneous Electrode (Model 3501)**

Subject: Important Medical Device Advisory Update to August 2019 Advisory – A total subset of approximately 38,350 active EMBLEM™ Subcutaneous Implantable Cardioverter Defibrillators (S-ICDs) (Models A209 and A219) with an elevated likelihood for early replacement (Boston Scientific Field Action Reference: 92400926D-FA)

Subject: Important Medical Device Advisory - EMBLEM™ S-ICD Subcutaneous Electrode (Model 3501) with a potential for electrode body fracture (Boston Scientific Field Action Reference: 92384167-FA).

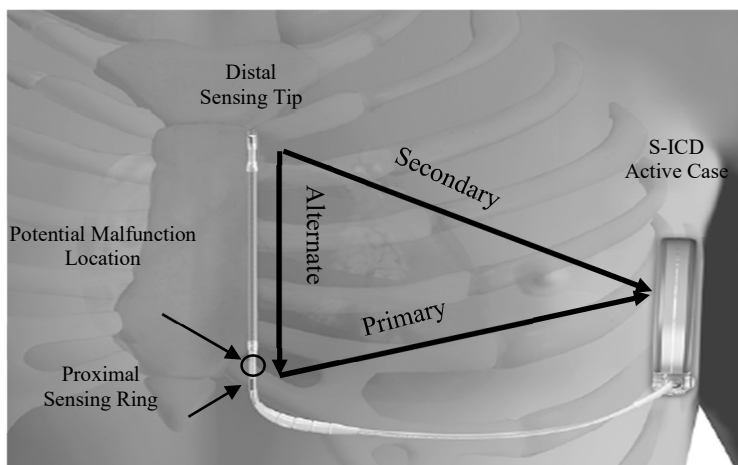
During assembly of the EMBLEM S-ICD Subcutaneous Electrode, a small amount of adhesive is applied to a location just distal to the proximal sense ring. Over time, mechanical stresses on the electrode body at this location may create the potential for a fatigue crack to initiate from the outer lumen. This crack then propagates inward toward the center-oriented distal sense conductor, eventually resulting in a fracture of the two high voltage conductors. To date, Boston Scientific has received 27 reports of electrode body fractures at this location; refer to Figure 1 for an image of the S-ICD system *in vivo*, note the potential fracture location with respect to the programmable sensing configurations (i.e., Primary, Secondary or Alternate).

Figure 1. S-ICD System *in vivo* depicting programmable sensing configurations and the potential malfunction location.

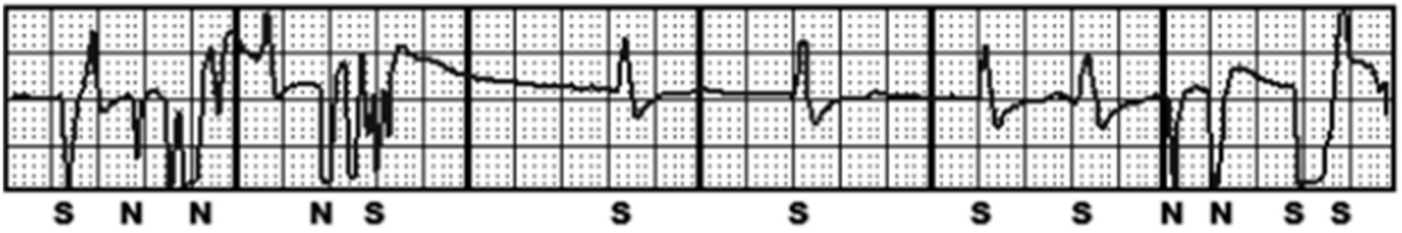
Figure 2. Example of non-physiologic, mechanical artifact; precursor artifact signals span one or both amplitude limits of the S-ECG.

For systems programmed in Primary sensing configuration, these precursor artifact signals are not encountered because the fracture initiates just distal to the proximal sensing ring. As a result, inappropriate shocks (IAS) will not be observed in Primary. In Primary sensing configuration, the first indication of an electrode fracture in the described location is the detection of a high impedance condition (i.e., alert with beeping tones). Based on the automated weekly integrity test’s algorithm, the alert condition occurs no later than eight days after both high voltage conductors fracture. This may occur sooner following an ambulatory shock post conductor fracture. If a fracture is suspected, radiographic imaging can aid in assessment of electrode integrity. Refer to Table 1 for a summary of the detection mechanisms based on sensing configuration.
