URGENT FIELD SAFETY NOTICE

Product Name: Secondary Sets containing Back Check Valve

Product codes: 72951NE, 72947NE, 72948NE, 72949NE, 72987NE

FSCA Identifier: RA-2016-12-02 Date:

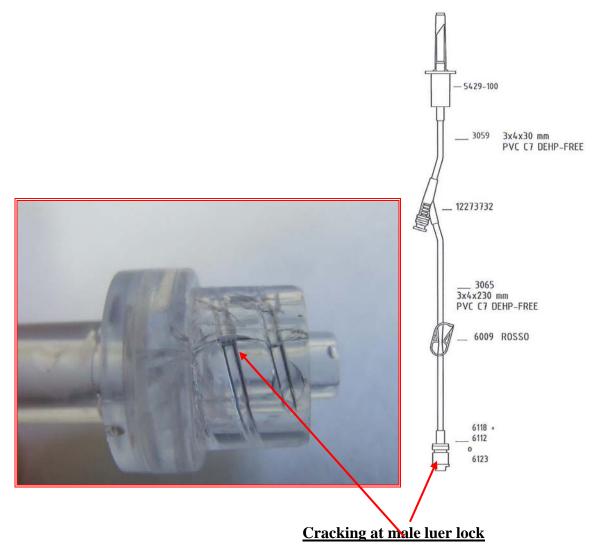
CareFusion has received reports of cracking of the secondary set back check valve male luer resulting in leakage of the infusion fluid. These secondary sets may be attached to a needle-free device that has been cleaned with a sanitising product containing IPA (Isopropyl Alcohol/PW 70%-30%) which appears to be contributing to the cracking of the plastic in this component.

In order that the potentially affected products are removed from use and destroyed please follow instructions below:

Step	Action				
1	Inspect inventory for product affected lot numbers of 72951NE - SECONDARY SET ONCOLOGY, 72947NE - AMBER SECONDARY SET BCV, 72948NE - Secondary set BCV, 0.2 micron filter, 72949NE - SECONDARY SET WITH INTEGRATED SMART-SITE, 72987NE - AMBER SECONDARY SET, VENTED, BCV (listed above)				
	If	Then			
	No affected lot numbers are found	Complete sections A & B of Appendix 1
