## **Urgent Field Safety Notice**

### **SynchroMed® II Implantable Infusion Pump - Models 8637-20, 8637-40**

#### **SynchroMed® II Missing Propellant - Physician Letter Important Patient Management Recommendations**

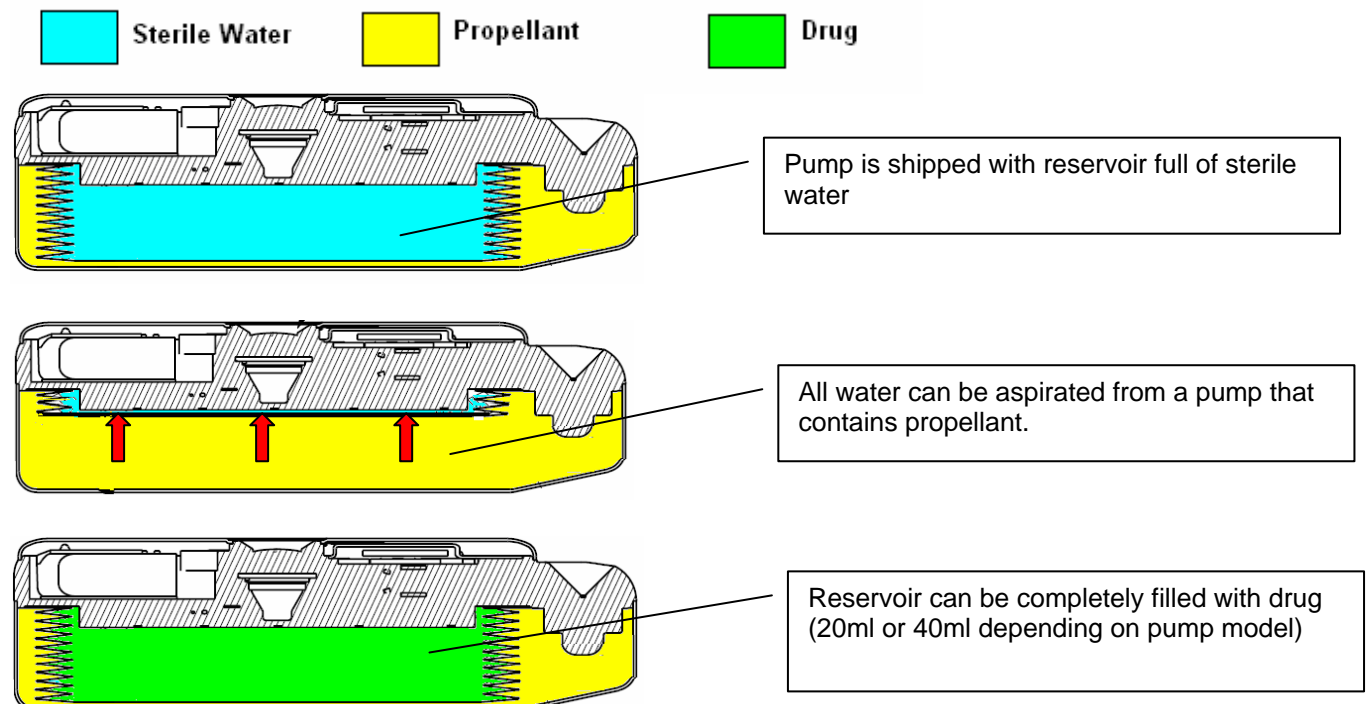
**Normal Pump**

Drug is contained in an expandable reservoir, also referred to as a ‘bellows’. The device is shipped with the bellows full of sterile water. The bellows is enclosed within the propellant chamber which contains a specific volume of propellant (in the form of a gas) that exerts pressure on the reservoir. The gas pressure is the primary force which drives drug to the pump mechanism, which dispenses drug based on the programmed rate. If a pump is missing propellant, at the point at which approximately one-half of the reservoir contents are removed, there will be insufficient force in the system to drive the drug to the pump mechanism, resulting in zero output from the device regardless of the programmed dispensing rate.

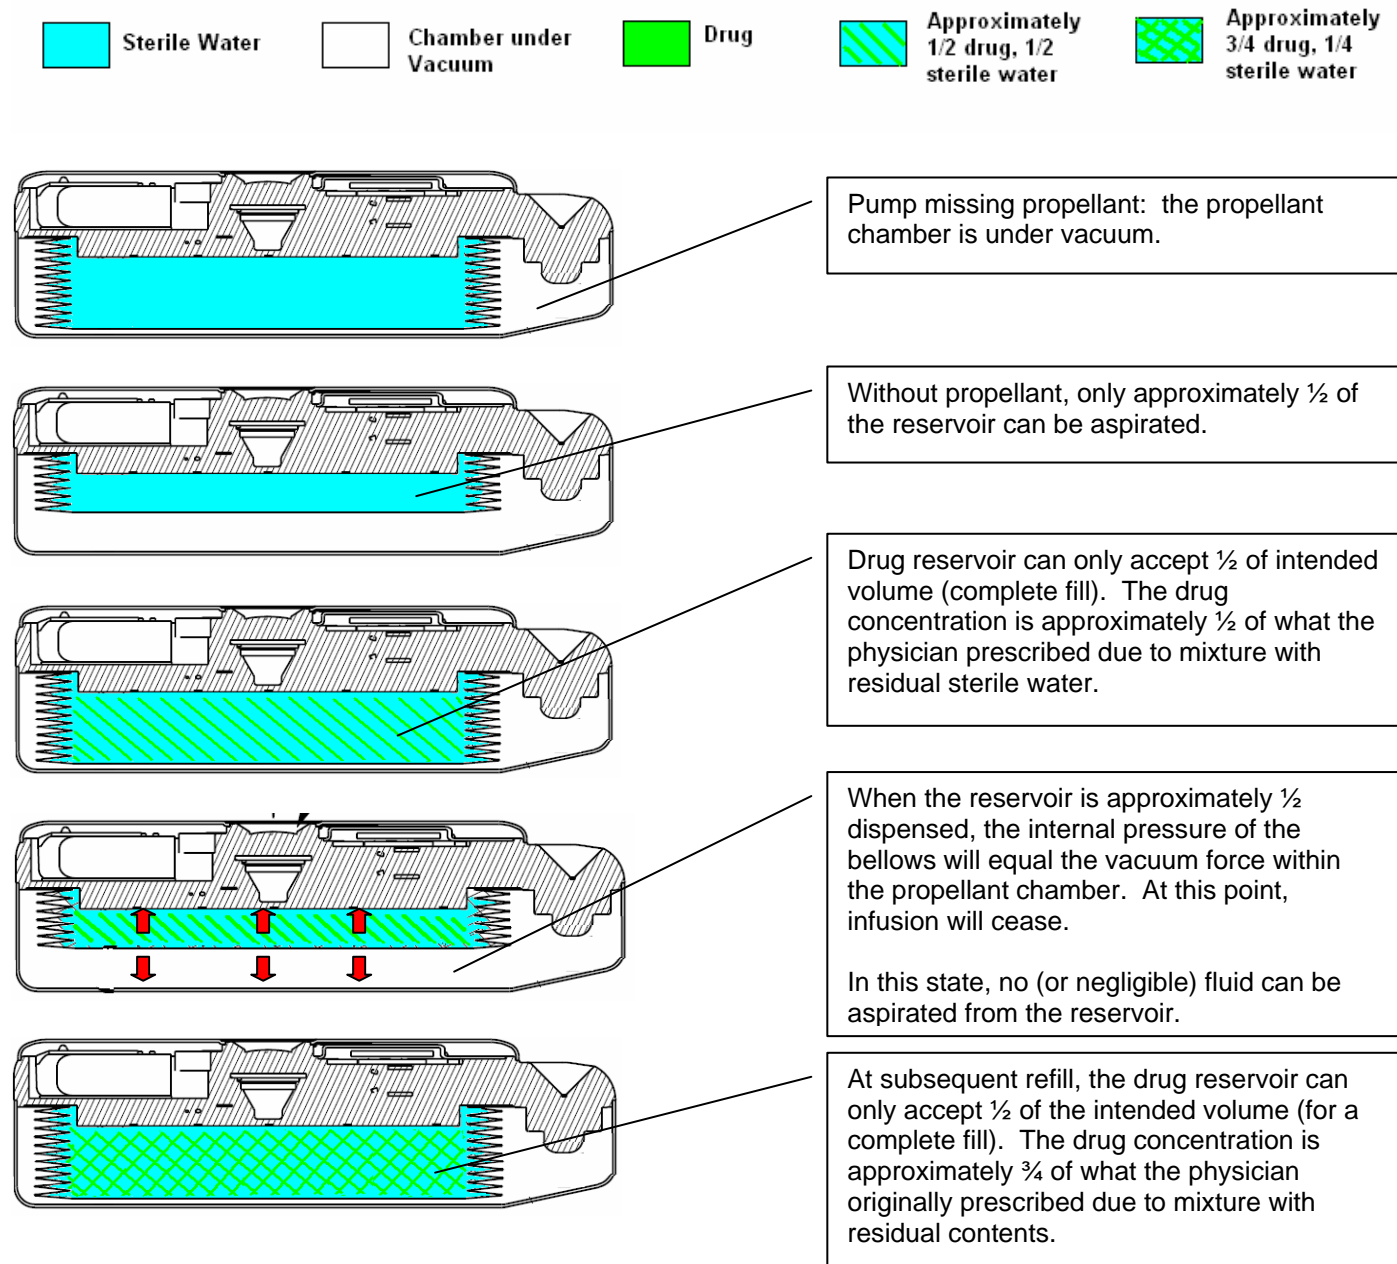
## Pump Missing Propellant

- 1) The reservoir contents cannot be fully aspirated
- 2) The pump can only dispense approximately 1/2 of the full reservoir volume
- 3) The reservoir will only accept approximately 1/2 of the reservoir volume (due to residual volume)

If a pump is identified as lacking propellant, Medtronic recommends the healthcare professional consider immediate pump replacement because proper drug delivery cannot be ensured, and because patient injury may result from drug dilution, underdose, overdose, or abrupt delivery cessation.
