## **Urgent Field Safety Notice**

### **Important Information on Potential MRI Effects**

#### **SynchroMed EL (Models 8626, 8627) and SynchroMed II (Model 8637) implantable infusion pumps**

Medtronic reference: FA403

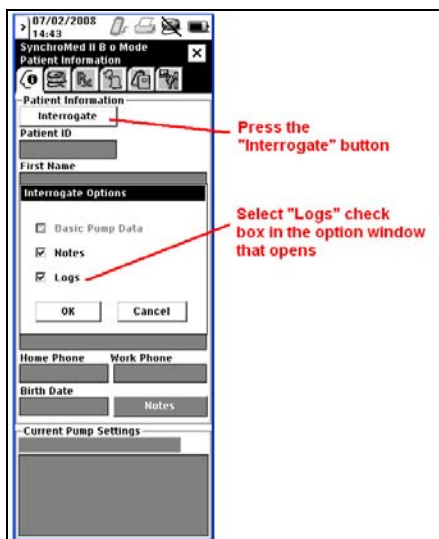
Figure 1

1. At least 20 minutes after completing MRI exposure, interrogate the pump using the clinician programmer and select the check box to download event logs (see Figure 1). If the event log states “*Motor Stall Occurred*” and “*Motor Stall Recovery Occurred*”, normal function of the pump has returned (see Figure 2).

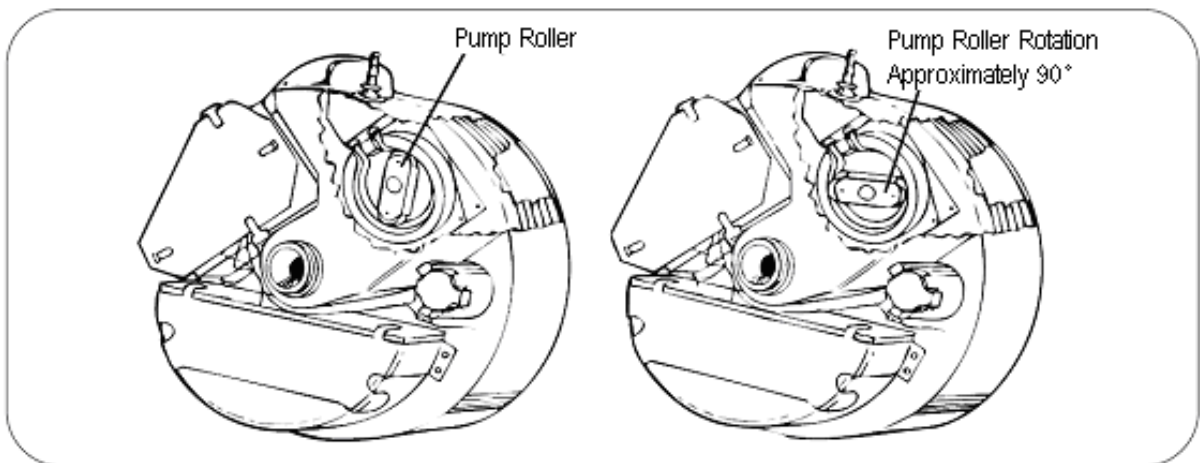
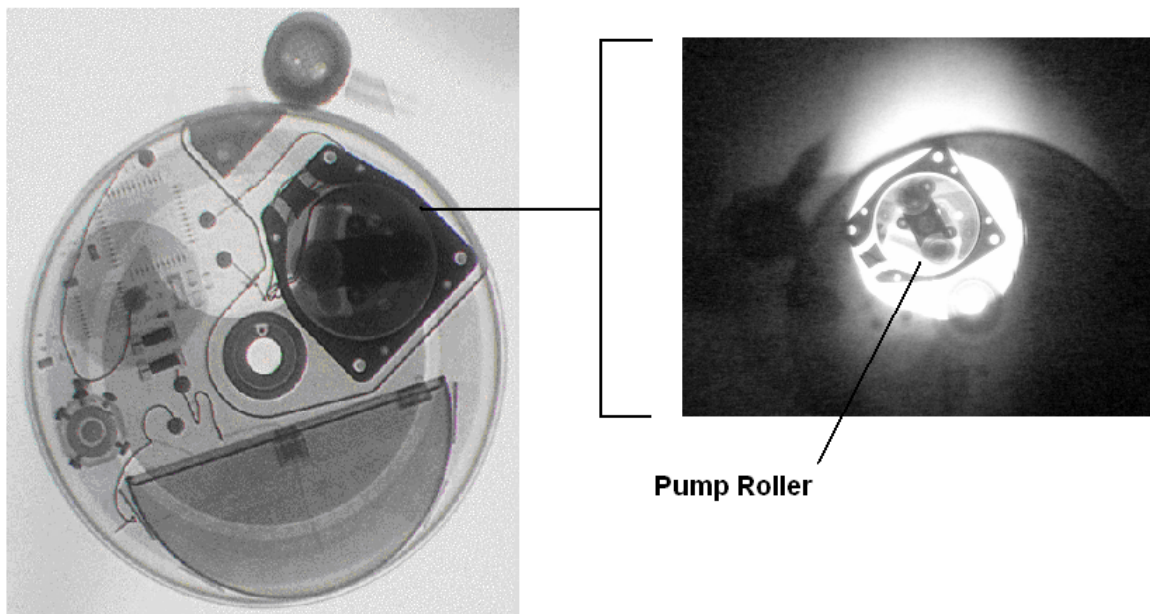
1. X-ray the pump to determine the location of the pump roller (overexposing the film will make the roller more visible). Several attempts may be necessary to visualize the roller.

6. X-ray the pump and determine the new position of the pump's roller. The pump's roller should have moved approximately  $90^\circ$ . Alternatively, fluoroscopy can be used to visualize the pump as it moves to its new position.

7. If there is no roller movement, the device may be stalled. Make copies of the pump status after update printout and the x-rays, then contact Medtronic, Inc. or your local Medtronic Representative.
