Important Medical Device Information

Cardiac Rhythm Management

September 2014

Summary

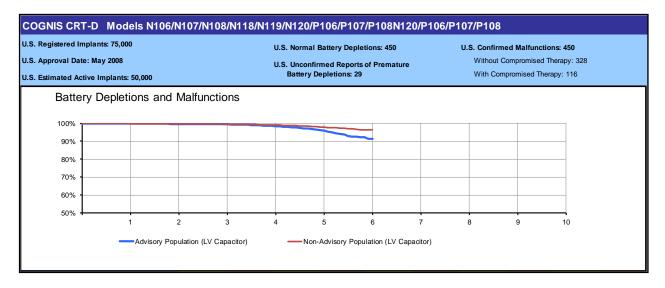
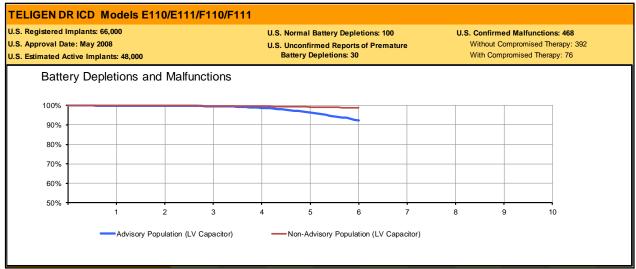
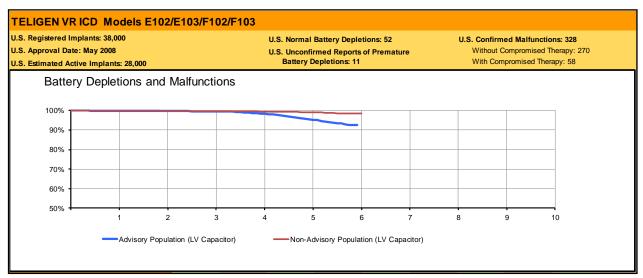
Appendix A

A total of approximately 267,000 COGNIS and TELIGEN defibrillators have been distributed and implanted since May of 2008. Overall Cumulative Survival, including normal battery depletion, is approximately 95% at 72 months (see Appendix A).

All-cause* Cumulative Survival for devices within and outside of the Low Voltage Capacitor Advisory subset population (United States data)

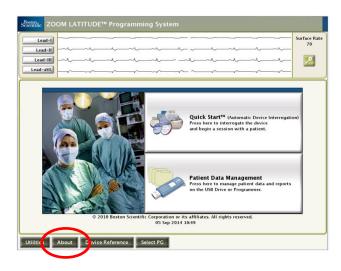
How can I tell if a Model 3120 Programmer has been updated with the new version of software?

• Look for Model 2868, version 3.04 under System Information on the About screen

Boston Scientific has recently introduced updated programmer software (Model 2868, version 3.04) that enhances the effectiveness of the Safety Architecture tools later in device life. We recommend that patients with a device in the advisory population be scheduled for an in-clinic follow-up at first opportunity, but within 3 months, using a programmer with the new software. In-clinic interrogation with an updated programmer will automatically download Safety Architecture software upgrades from the programmer into individual patient devices, enhancing detection of a compromised LV capacitor before therapy delivery is impacted. See Appendix B for additional information on how to identify the current version of programmer software.
