URGENT FIELD SAFETY NOTICE

Release of a new software version to maintain therapies in implanted Platinum devices in case of occurrence of the hardware failure described in the Field Safety Notice issued in July 2018

FSCA identifier: CRM-SAL-2018-001-C

Affected devices: Limited subset of Platinum Implantable Cardiac Defibrillator (ICD) and Resynchronization Therapy Defibrillator (CRT-D) models : VR 1210, VR 1240, DR 1510, DR 1540, CRT-D 1711, SonR CRT-D 1811, CRT-D 1741, SonR CRT-D 1841, 4LV CRT-D 1744, 4LV SonR CRT-D 1844

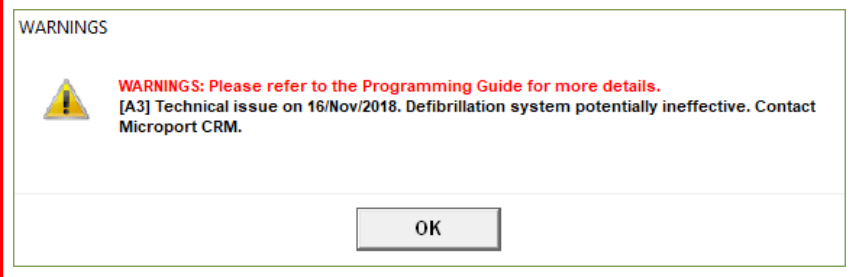
This new software is not able to eliminate the underlying hardware failure. The overconsumption resulting from the failure will not be interrupted. **The warning “Technical issue” will be raised, indicating that overconsumption has been detected. This alert will be sent remotely or observed during in-clinic follow-up. A minimum service period of 45 days after hardware failure is guaranteed.**
