Urgent Field Safety Notice

Adapta™, Versa™, Sensia™, Relia™, Attesta™, Sphera™, and Vitatron™ A, E, G, Q Pacemakers Software Update

September 2019

Medtronic reference: FA857 Phase II

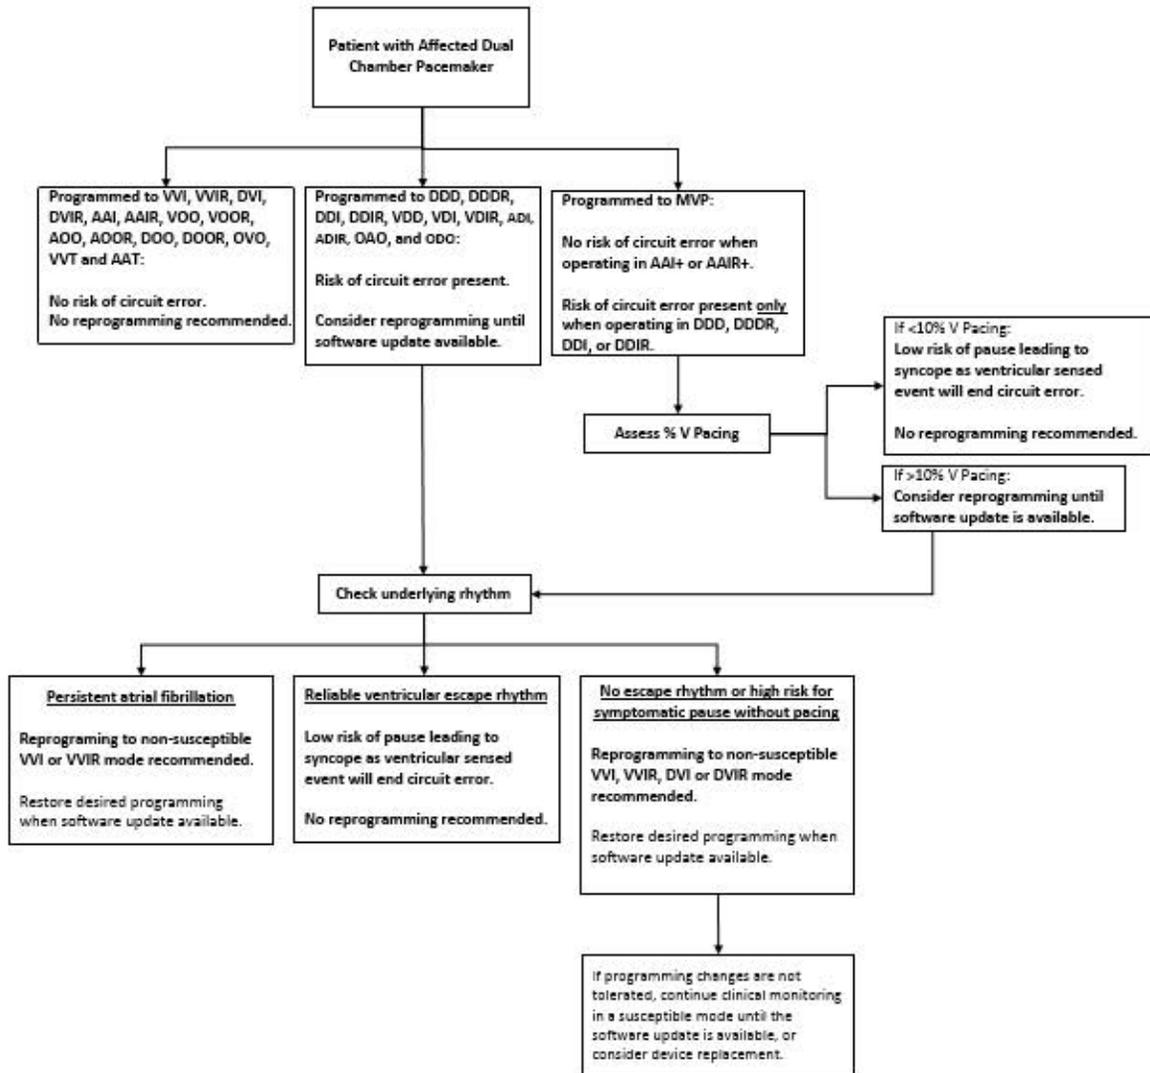
Appendix A: Programming decision flow chart

We realize that each patient requires unique clinical considerations. In consultation with Medtronic's Independent Physician Quality Panel (IPQP), **Medtronic recommends programming to a non-susceptible pacing mode as the primary mitigation for patients implanted with an affected device until the software update has been installed.** Specific patient risk assessment and programming recommendations are outlined below and provided in Appendix A.

- **For patients whose device is programmed to a non-susceptible mode (see Table 1), no action is needed at this time. Continue routine clinical monitoring.**

- **For patients whose device is programmed to a susceptible mode and are continually in persistent atrial fibrillation, reprogramming the device to the non-susceptible VVI or VVIR mode is recommended to eliminate risk due to this issue until the software update has been installed. Continue routine clinical monitoring.**

- **For patients whose device is programmed to a susceptible mode and either: *have no underlying ventricular escape rhythm; or are at risk for a symptomatic pause until a ventricular escape beat occurs*, programming to a non-susceptible mode is recommended to eliminate risk due to this issue until the software update has been installed. Continue routine clinical monitoring.**

- **For patients who do not tolerate programming to a non-susceptible pacing mode and either: *have no underlying ventricular escape rhythm; or are at risk for a symptomatic pause until a ventricular escape beat occurs*, continue clinical monitoring in a susceptible mode until the software update is available, or consider device replacement.**

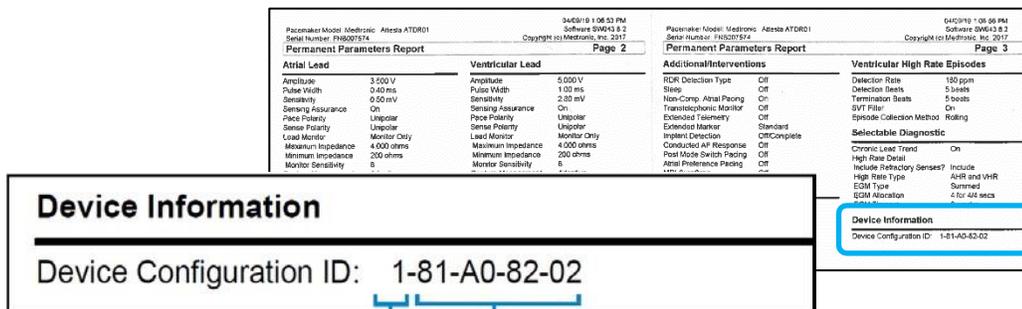
14. Verify the "Device Configuration ID" at the bottom of the Parameters Report starts with "1-".

Look for "1-" These values may differ

If it starts with "1-", the pacemaker has been updated successfully.
No further action is required.
