Urgent Field Safety Notice
Programmer Software Update
Supporting the Micra™ Transcatheter Pacing System

Model
2090 CareLink™ Programmer
29901 Encore™ Programmer
CareLink Network Application Software 2491

January 2019

Medtronic reference: FA856

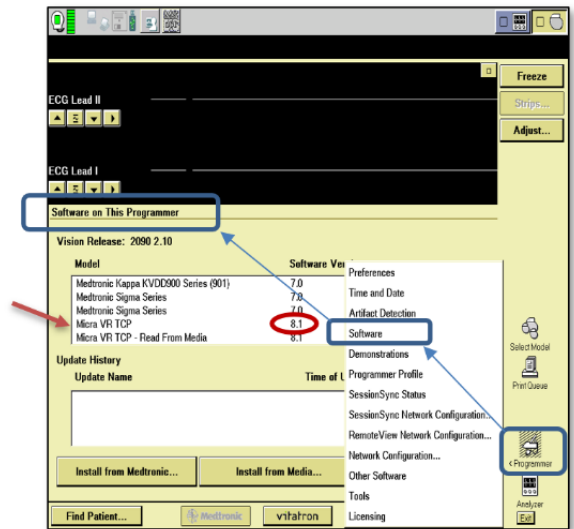
Image 1

Correct software: Micra VR TCP version 8.1 (or higher)

- Select Software (see image 1)
- Scroll through the list of available Software Models in the top selection box until you locate the Micra selection
- Verify the Software Micra VR TCP Version is 8.1
