**Subject:** Urgent Field Safety Notice Software Update – Minute Ventilation Sensor Software Update Available for Pacemakers (see previous communication issued in December 2017 with reference 92186345-FA).

## **Summary Field Safety Notice (FSN)**

# Boston Scientific Software Update for MV Sensor Oversensing

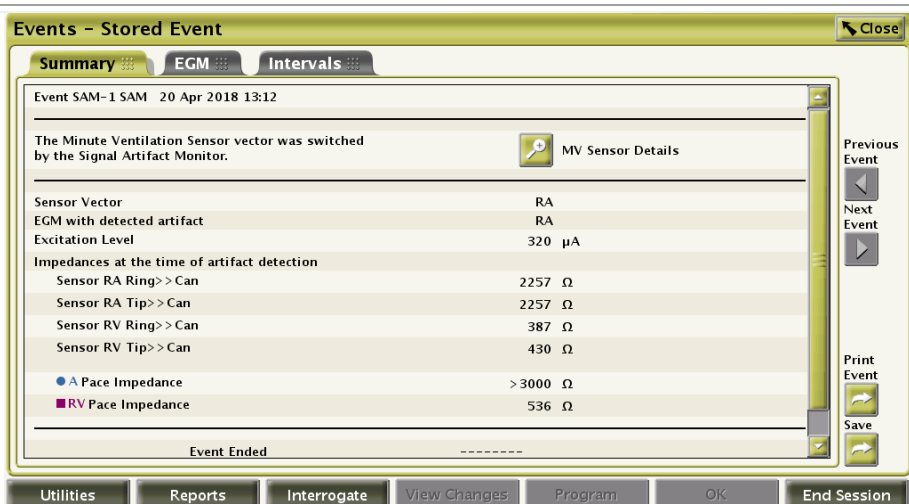
**Table 3.** Example of Signal Artifact Monitor episode with associated vector and lead impedance values.

A SAM episode includes an EGM and the associated sensor vector and lead impedance values. The RA/RV ring>>can and tip>>can impedances are new diagnostic data that along with the pace lead impedances may be helpful in identifying whether there is a compromise in lead integrity or lead connection (see Table 3).

In this example the RA Tip/Ring>>Can and A Pace Impedance are out of range.

- Sensor RA/RV Ring >>Can is 100-1500Ω
- Sensor RA/RV Tip >>Can is 200-2000Ω.
