Urgent Field Safety Notice

Type of Action: Advisory

The SynCardia TAH-t System

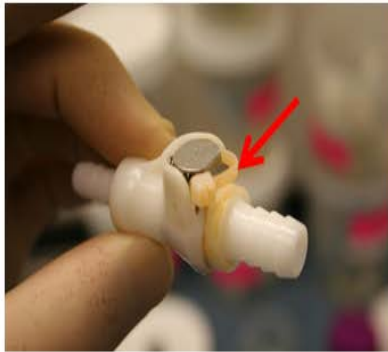
The spring inside the female CPC connector housing may become displaced inside or dislodged from the housing when the wire (zip) tie is inserted or removed incorrectly from the CPC connector during or after a Driver exchange/switch, preventing disconnection of the cannula and exchanging of Drivers. **See Figures 1-3**

Figure 1
Wire Tie at CPC Junction

- **Patients**
 - Must return to clinical site for CPC connector repair and/or exchange
- **Clinicians**
 - In the event of a displaced spring on the left side cannula CPC connector, it is recommended that the CPC connector be replaced.
 - Replacement is accomplished by attaching a new CPC connector onto a pumping TAH-t Driver system driveline and then cut the securing wire ties on the patient cannula hose barb.
 - Remove the hose barb from the patient cannula and immediately insert the hose barb of the new CPC connector that is pumping on the new driver. Secure the cannula with new wire ties.
 - Repeat this on the other ventricle side if needed.
 - If there is no need to change the right, male, CPC connector, just attach the new Driver Right Driveline to the blue, right, cannula fitting.

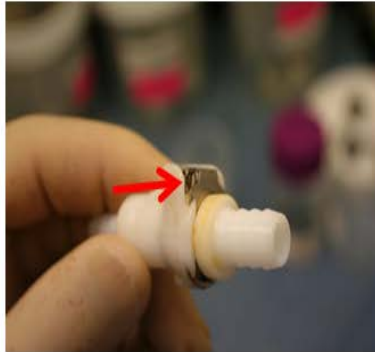
Figure 2
Displaced CPC Spring

The probability exists that the CPC spring displacement related to the wire ties may result in serious adverse health consequences that may be transient in nature and/or require medical intervention. The probability is remote ($0.001\% < F \leq 0.1\%$) based on the estimated rate of injury occurrence associated with CPC connector malfunctions reported to SynCardia. The primary risk of injury could be caused by a more difficult disconnection of the cannula and drivelines which may impact the ability to complete a driver exchange in a timely manner that could result in a loss of power to the TAH-t.

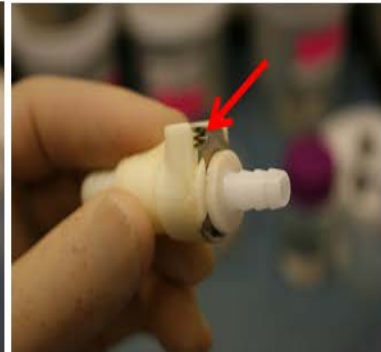
Figure 3
Correctly Seated CPC Spring
