Urgent Field Safety Notice

Model A610 DBS Version 3.0.x

Clinician Programmer Tablet Application Displays System Error During Interrogation -
Software Update

Medtronic Reference: FA1188

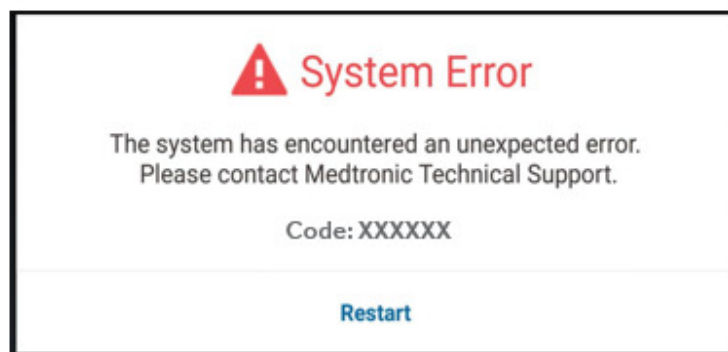
Under these circumstances, the clinician programmer application may display a recurring system error and terminate the session, preventing interrogation or programming of the device. The patient will continue to receive therapy and the patient programmer can be used to adjust therapy within clinician set limits.

If this issue occurs, you will encounter a system error message similar to the one below:

Error codes seen with this issue include, but may not be limited to, codes 0x4b81f1a3 and 0x791ebfe0.

If you experience this recurring system error message, contact your Medtronic Representative. Medtronic is developing a software update to address this issue and will inform you once this is available.
