Urgent Field Safety Notice

Intellis™ Data Validation System Error Model A710 Software Update to Version 1.3.130 Software update

December 2020

Medtronic Reference: FA949

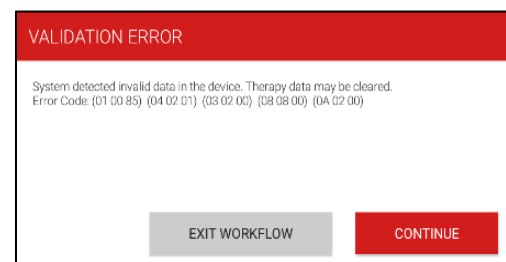
Figure 1: Validation Error Prompt

Medtronic has received fourteen (14) reports between January 2020 and November 24, 2020 where users encountered this validation error (Figure 1) followed by a system error (Figure 2) on the CT900 Clinician Programmer A710 Intellis Software Application version 1.3.80 indicating that the stimulator programming update could not be completed. After investigation, it was determined that there was corruption within a specific location of the stimulator memory and the A710 Intellis Software application version 1.3.80 did not clear the corruption as it was designed to, resulting in a system error. This system error is not a frequent event and the occurrence rate has been reported as lower than 1 in 10,000.

This issue occurs and is recognized in the clinical setting where the patient is under the care of the healthcare professional. If you are presented with the VALIDATION ERROR (as shown) with Error Code (01 00 85) (04 02 01) (03 02 00) (08 08 00) (0A 02 00) **before** installing the latest A710 Intellis Software Application v1.3.130, please select the **"CONTINUE"** option. If **"EXIT WORKFLOW"** is selected, please reestablish communication and select **"CONTINUE"** when presented with the VALIDATION ERROR (figure 1).

Please download the latest update to the A710 Intellis Software Application, version 1.3.130, to the CT900 Clinician Programmer following the enclosed instructions.

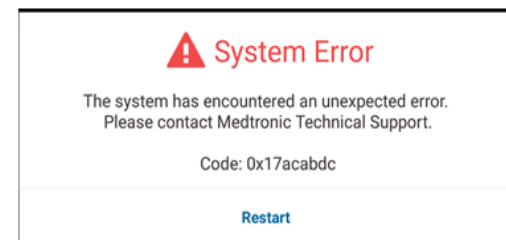
Figure 2: System Error Prompt

After selecting the **"CONTINUE"** option, if this **"System Error"** (Figure 2) is displayed, please contact your Medtronic representative responsible for your facility or contact our Neuromodulation Technical Scientific Service at Tel. 02159/8149-171 for help in downloading the latest A710 Intellis Software Application v1.3.130. After downloading the newest Intellis Software Application v1.3.130, please reestablish communication and select **"CONTINUE"** to correct this issue.
