Urgent Field Safety Notice

July 2022

Subject: Field Safety Notice – Continued use of older Model 2868 software on Model 3120 ZOOM™ programmers to support transvenous CRT-Ds and ICDs until supply chain constraints on newer programmers¹ are resolved. See Appendix A for affected GTINs (Boston Scientific Field Action Reference: 92822246-FA)

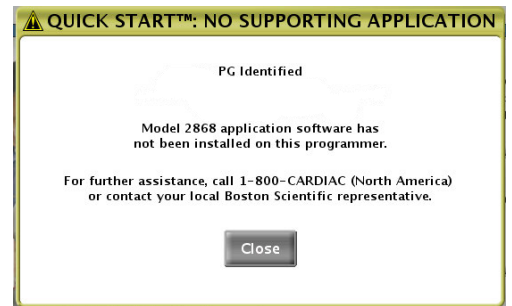
As part of this software upgrade, product labeling was updated to direct users to avoid using outdated 2868 software and Boston Scientific began uninstalling this software from 3120 ZOOM programmers. Soon after, Boston Scientific became aware of the likelihood of pandemic-induced global supply chain constraints on 3300 LATITUDE programmer supply and discontinued the uninstallation process in most regions because there could be insufficient programmers to support implanted TV defibrillators. When 2868 software is uninstalled, the 3120 ZOOM programmer can no longer interrogate TV defibrillators. If a user attempts to interrogate a device without applicable software, a message is displayed (Figure 2) to notify the user that software has been uninstalled on the programmer. To determine if a programmer has 2868 software, select “About” on the programmer screen and review the list of software applications installed. Please note that, 2868 software is the only outdated application on the 3120 ZOOM programmer.

Figure 2. Message that displays when a Boston Scientific TV defibrillator is interrogated by a 3120 ZOOM programmer if 2868 software is uninstalled.

The behavior most likely to be attributed to potential harm when using a 3120 ZOOM programmer is the inability to interrogate a TV defibrillator (e.g. Figure 2 or 3). There have been 9 reports of this behavior which have resulted in a delayed/prolonged procedure until the defibrillator can be interrogated with a 3300 LATITUDE programmer. Furthermore, there has been a single report of delays in reprogramming for phrenic nerve stimulation and a single report of an inability to interrogate for delivery of commanded therapy. None of the reports associated with 3120 ZOOM programmer have resulted in permanent injury.

- 1) If unable to interrogate a TV defibrillator with a 3120 ZOOM programmer, use a 3300 LATITUDE programmer instead. If this behavior occurs, STAT PACE, STAT SHOCK, and DIVERT THERAPY programmer operations⁴ are not available through a 3120 ZOOM programmer, so external pacing/defibrillation or magnet application (to divert shock) may be required if a 3300 LATITUDE programmer is not immediately available.

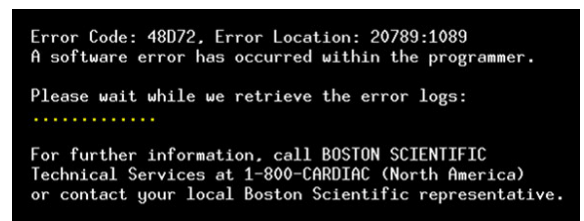
If a TV defibrillator has a stored SAM episode, the 3120 ZOOM programmer will present the Error Log and Halt message in Figure 3, and the user will need to use a 3300 LATITUDE programmer to interrogate the defibrillator. This error message (Figure 3) is an indication of an incompatibility of any 3120 ZOOM programmer with that specific TV defibrillator. However, the TV defibrillator will operate as intended with the permanently programmed settings. After power cycling the programmer, it may be used to interrogate TV defibrillators without stored SAM episodes. If the user attempts to interrogate the same TV defibrillator with the 3120 ZOOM programmer, the Error Log and Halt message will display again.

Figure 3. The specific Error Log and Halt Message on 3120 ZOOM Programmer when interrogation of TV defibrillator with a SAM episode is attempted.

A 3120 ZOOM programmer update to 2868 software has been developed to resolve the Error Log and Halt behavior associated with TV defibrillators having a stored SAM episode. This software update does not represent a material reduction in patient safety risk, however, it does prevent clinical workflow interruptions and will be released subsequent to approval.
