Urgent Field Safety Notice

Risk of Minute Ventilation artefact oversensing in patients with a subset of abnormal high polarization XFine passive pacing leads, when connected to ALIZEA / BOREA pacemakers.

FSCA identifier: CRM-SAL-2022-001

Affected devices: Subset of MicroPort CRM XFine leads (models XFine TX25D, XFine TX26D, XFine JX24D; XFine JX25D) connected to MicroPort CRM ALIZEA or BOREA pacemakers (models ALIZEA DR 1600, ALIZEA SR model 1300, BOREA DR model 1500, BOREA SR model 1200).

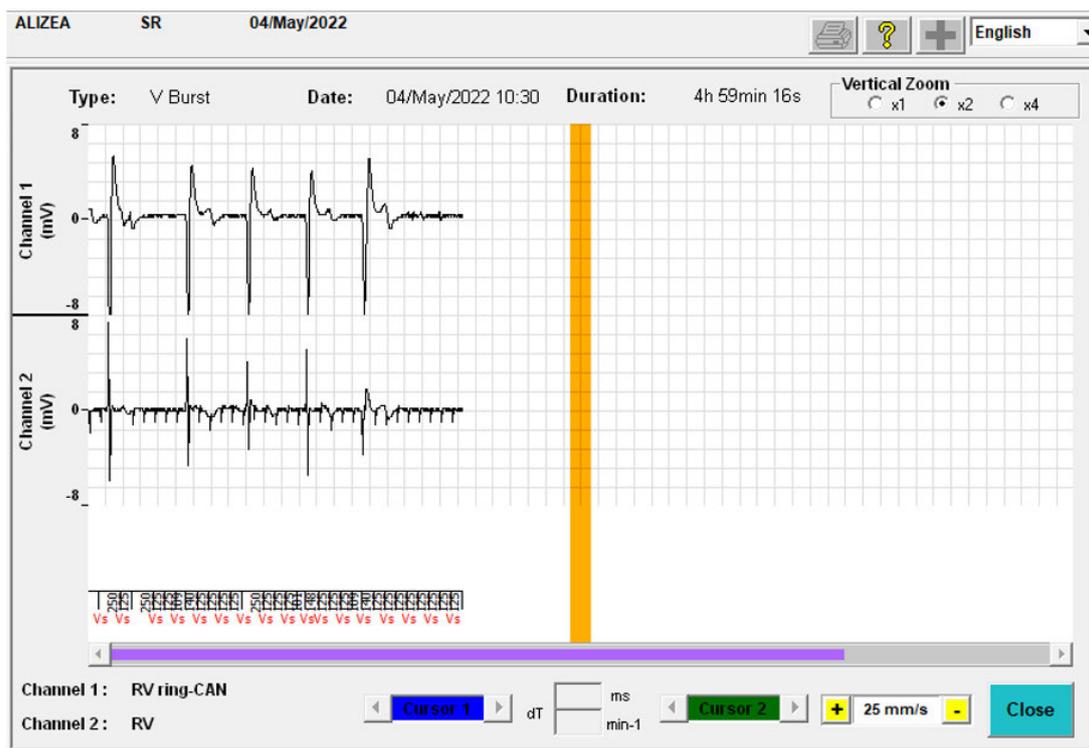
MV noise oversensing is characterized by the presence of repetitive 125ms or 250ms cycles (as illustrated below), visible in:

Figure 2: Illustration of “V Burst” episode due to MV noise oversensing on an SR pacemaker

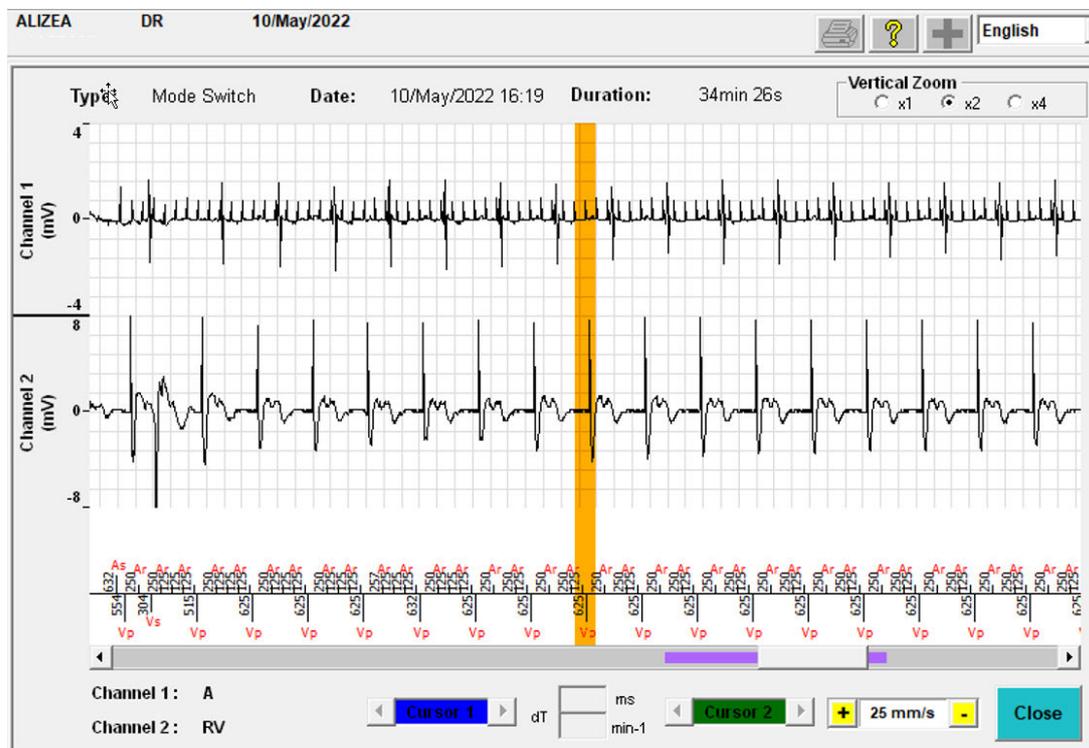
Figure 3: Illustration of “Mode Switch” episode due to MV noise oversensing on a DR pacemaker
