Urgent Field Safety Notice

HeartWare™ Ventricular Assist Device (HVAD™) System

Communication update regarding failure/delay to restart pump events

Medtronic Reference: FA944

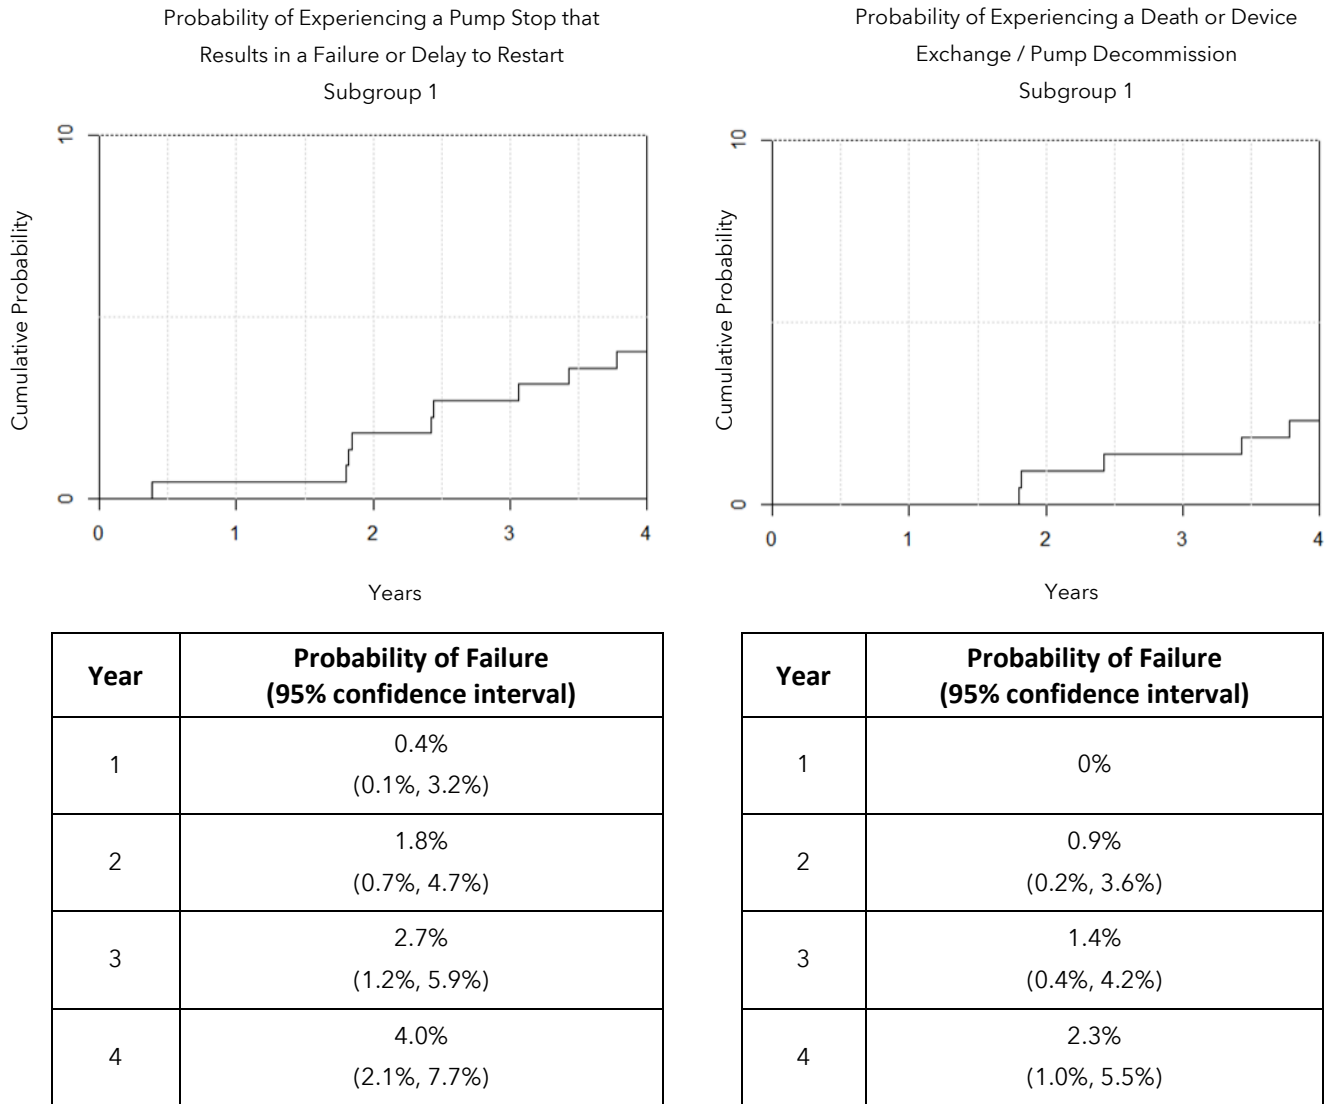
SUBGROUP 1

Figure 1: Cumulative incidence of experiencing a pump stop with delay/failure to restart (left) and the cumulative incidence of failures leading to a pump exchange or death (right) in Subgroup 1.

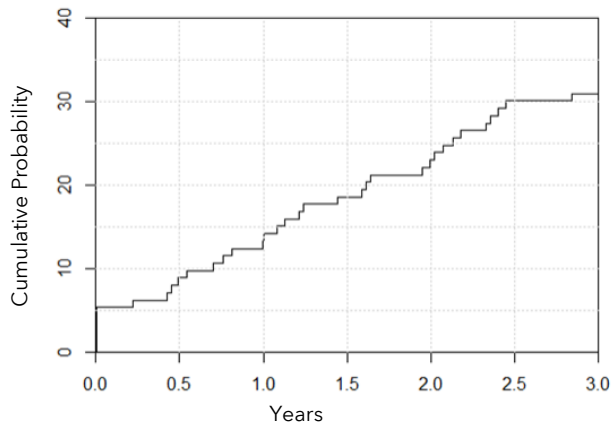
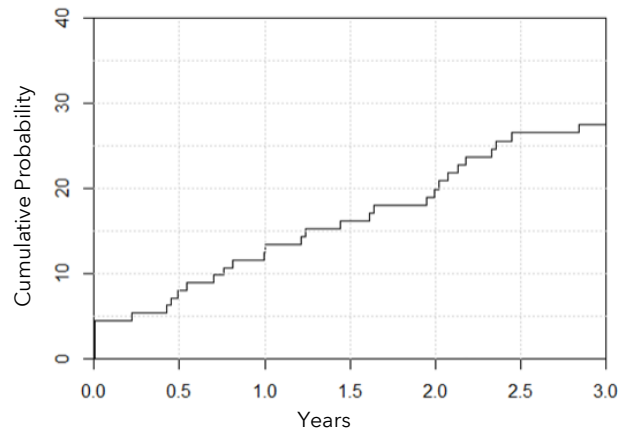
SUBGROUP 2

Year	Probability of Failure (95% confidence interval)
1	13.3% (8.3%, 21.3%)
2	23.0% (16.4%, 32.2%)
3	31.0% (23.5%, 40.8%)

Year	Probability of Failure (95% confidence interval)
1	12.5% (7.6%, 20.3%)
2	19.9% (13.7%, 29.0%)
3	27.5% (20.3%, 37.4%)

Figure 2: Cumulative incidence of experiencing a pump stop with delay/failure to restart (left) and the cumulative incidence of failures leading to a pump exchange or death (right) in Subgroup 2.

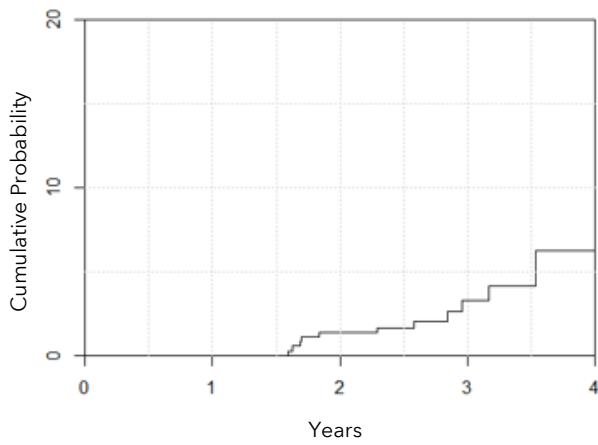
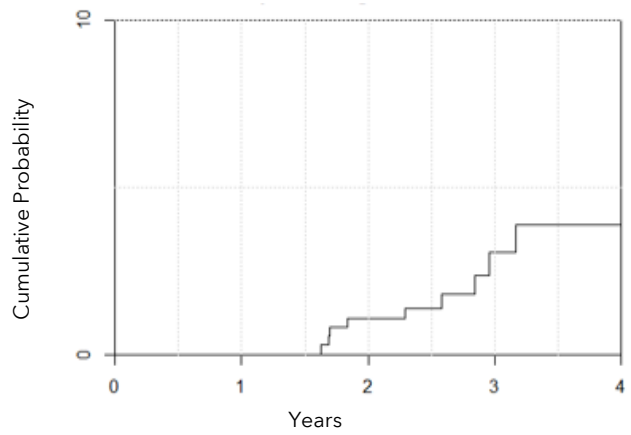
SUBGROUP 3

Year	Probability of Failure (95% confidence interval)
1	0%
2	1.3% (0.6%, 3.2%)
3	3.3% (1.7%, 6.6%)
4	6.2% (2.9%, 13.3%)

Year	Probability of Failure (95% confidence interval)
1	0%
2	1.1% (0.4%, 2.8%)
3	3.0% (1.5%, 6.3%)
4	3.9% (1.9%, 7.9%)

Figure 3: Cumulative incidence of experiencing a pump stop with delay/failure to restart (left) and the cumulative incidence of failures leading to a pump exchange or death (right) in Subgroup 3.

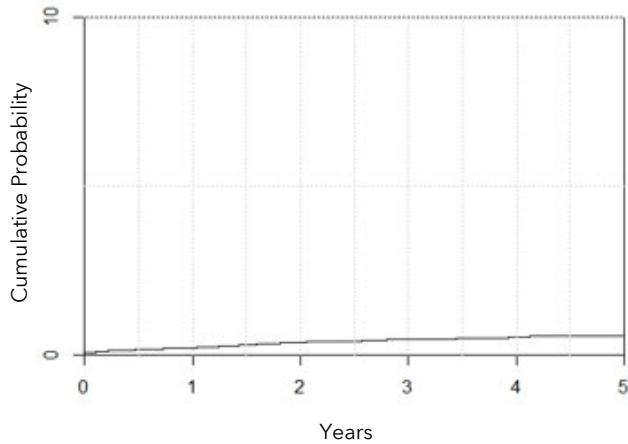
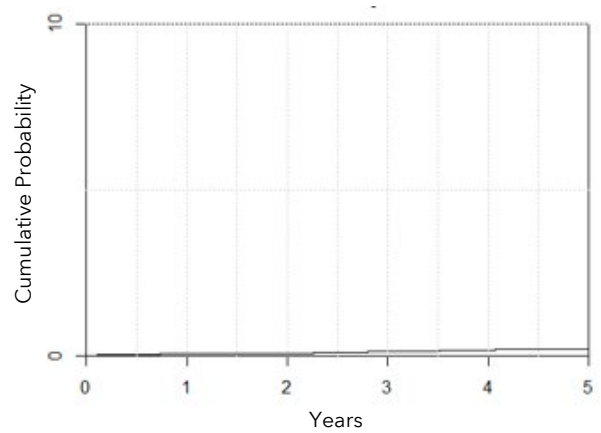
GENERAL POPULATION PUMPS

Year	Probability of Failure (95% confidence interval)
1	0.2% (0.1%, 0.3%)
2	0.4% (0.3%, 0.5%)
3	0.5% (0.3%, 0.6%)
4	0.5% (0.4%, 0.7%)
5	0.5% (0.4%, 0.7%)

Year	Probability of Failure (95% confidence interval)
1	0.04% (0.01%, 0.1%)
2	0.05% (0.02%, 0.1%)
3	0.1% (0.07%, 0.2%)
4	0.2% (0.1%, 0.3%)
5	0.2% (0.1%, 0.3%)

Figure 4: Cumulative incidence of experiencing a pump stop with delay/failure to restart (left) and the cumulative incidence of failures leading to a pump exchange or death (right) in the general population.
