URGENT – FIELD SAFETY NOTICE

Nimbus 4 & Nimbus Professional mattress – risk of over-inflation

Affected Product: Arjo Nimbus 4 & Nimbus Professional mattress

Field Safety Notice: FSN-SUZ-001-2021

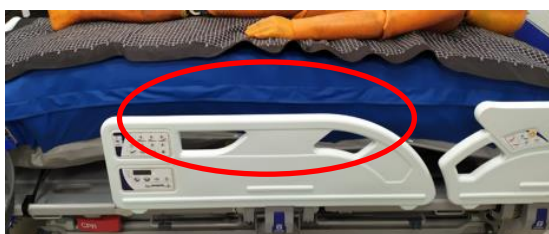
Arjo has received limited reports of the Nimbus 4/Professional mattress over-inflating which requires an unusual set of circumstances to occur. This is a very rare occurrence and there have been no reports of health consequences to either patients or caregivers due to this issue.

Our investigation has concluded that there is a remote possibility that a patient could fall from the mattress if the issue was to occur and was not detected by care givers. The issue is caused by inner mattress components that may fail after a certain period of time, however this is extremely rare and unfortunately cannot be detected until the product is disassembled.

Malfunctioning mattress

1. Transfer the patient to another appropriate surface
2. Turn off and unplug the pump.
3. Perform grommet membrane deactivation as instructed in the video to allow the accumulated air to freely vent out. Use a screw driver with a diameter of 2 – 3 mm. Make sure that the membrane is punctured through.

NOTE: The grommet membrane restricts the volume of excess air escaping. Removing the membrane will not affect mattress functionality in any way other than to allow excess air to escape at a slightly higher rate. This process does not introduce any new risks.
