<b>Hillrom™</b> Hillrom Luleå Nedre Vägen 100, 975 92 Luleå, Sweden	<b>Field Safety Notice</b>	  <b>FA-2021-11-004-LUL-002</b>
---	----------------------------	--

**FSCA-identifier:** FA-2021-11-004-LUL-002

**Commercial name of the affected product,**  
Traverse Rail Carrier and Traverse Rail Carrier E-System, wide

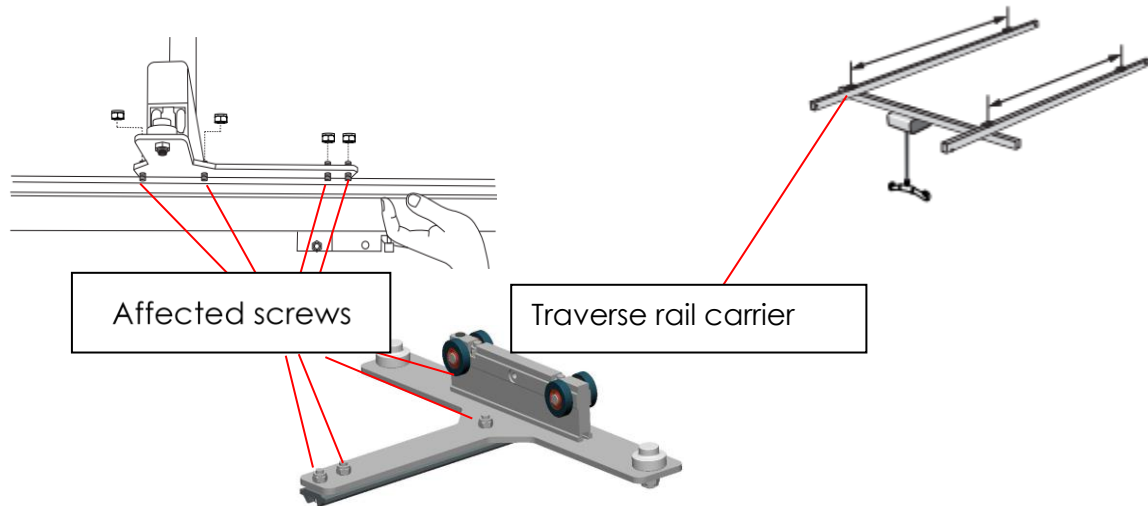
Figure 1

A traverse system consists of two primary rails with a secondary rail in-between. See figure 1 below.

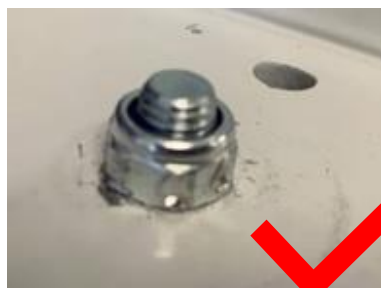
Hillrom received an out of box complaint where it was discovered that the traverse carrier had been delivered with the incorrect, non-conforming screws. The length of the screws according to specification is M8X25 (25 mm) whilst the screws of the affected batch were M8X20 (20 mm). M8X20 does not lock against the nyloc nut when installed per the installation instructions, as per figure 2 (correct screw) and figure 3 (incorrect screw) below.

Figure 2 - conforming

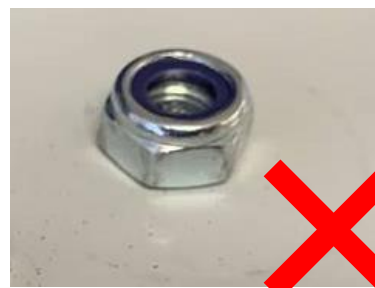
Figure 3 - non-conforming

Should the system be installed with non-conforming short screws and fail, there is potential for a patient and/or caregiver to be hit by falling objects or dropped from the lift, causing a potentially catastrophic injury.

Hillrom will arrange a site visit to inspect the potentially affected units. If short screws are identified, they will be exchanged with those of correct length.
