Type of Action: Field Safety Notice

Field Action Identifier: FA 2021-010-002-LUL-001

Subject: Missing bushing on Liko M220 and M230 causing wear and potential for falls.

Commercial name of affected product: Liko M220, Liko M230

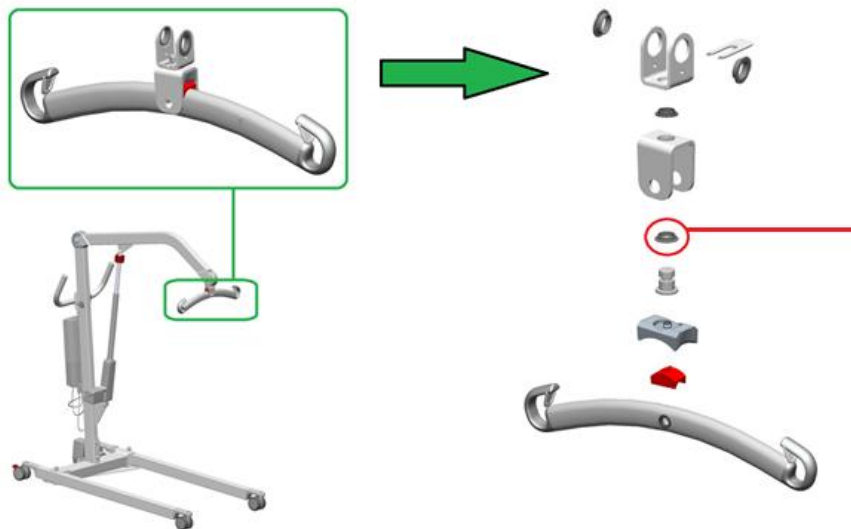
Hillrom has received customer complaints whereby a Slingbar had detached from the upper bracket of the sling bar attachment. Investigations indicated that a bushing was missing on the product. The missing bushing causes wear on the Slingbar attachment, which in turn can potentially cause the sling bar to detach from its attachment. If the slingbar detaches from the upper bracket, this has the potential for patient falls.

Figure 1: Mechanism and parts included in the sling bar for M220/M230. Bushing marked in red.

Hillrom investigation determined that the root cause of the slingbar detachment is caused by wearing at the slingbar attachment due to the missing of a plastic bushing (see red markings in Figure 1) as part of the assembly during manufacturing of the device. It was determined that assembly of this device has the potential to not contain this plastic bushing on devices manufactured between 2016-DEC-27 and 2021-SEP-01.

Upon receipt of the response form, identifying potentially impacted devices, Hillrom or an official Hillrom distributor/representative will be in contact to schedule inspection of your device to confirm presence of the bushing. Where it is confirmed that the device is missing the bushing, a replacement slingbar with the bushing will be installed.
