Important service note

XO 4 Suction tube holder on patient's chair

May 2009
YB-545

Compulsory replacement of bolt – suction tube holder on the XO 4 Patient's Chair!

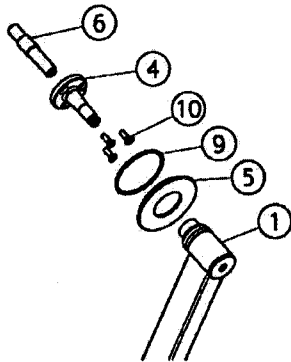
Unfortunately, it has recently come to our attention that there may be serious problems with the threaded bushing that replaces the factory attached bolt used for attaching the suction tube holder to the XO 4 patient's chair. See the sketch below:

The part in question is at position 6 on the sketch, item number MG-783. The problem is that, at one point, our supplier mistakenly delivered threaded bushings with a different surface treatment to the one specified by us. As a result, this may cause the threaded bushing to be of a lower strength than is required.

Consequently, all threaded bushings delivered during the period 01-01-2008 to 01-04-2009 must be replaced with the correct type.

For this purpose we are sending you a small kit, item number: AO-549 "KIT REPLACEMENT OF MG-783", containing a new threaded bushing, new Torx screws for attaching the axel, locking screws and mounting instructions.
