URGENT: DEVICE CORRECTION

Zimmer® Trabecular Metal™ Dental Implant, 4.1mmD

Nature of Correction: Updated Instructions for Use for Select Patients

Subject: Precaution when placing a Zimmer Trabecular Metal Dental Implant 4.1mmD in mandibles with dense (Type D1), thick, inferior border

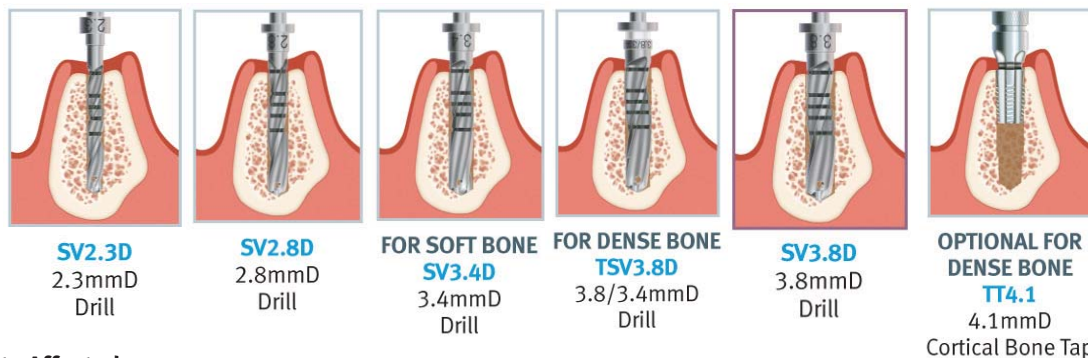
Zimmer Dental has an additional precaution when placing the 4.1mmD Zimmer Trabecular Metal Dental Implant in mandibles with a dense (Type D1), thick, inferior border where apical implant engagement is expected.

Follow the dense bone protocol for the 4.1mmD Trabecular Metal Dental Implant with the following exception. After the drill sequence step using the TSV3.8DN or TSV3.8DSN, add an additional drill step utilizing the SV3.8DN or SV3.8DSN drill. If needed, also use the optional TT4.1 Cortical Bone Tap. This correction will provide a wider apical osteotomy to ensure that the apical tip of the implant is not subjected to excessive torque during the final seating process.

When placing the 4.1mmD Trabecular Metal Dental Implant in mandibles with a dense (Type D1), thick, inferior border where apical implant engagement is expected, follow the drilling sequence and protocol (with optional tap) as described below.
