**Customer Information**  
**MR SENSE Head Receive Coil Assembly**

## Customer Information MR SENSE Head Receive Coil Assembly

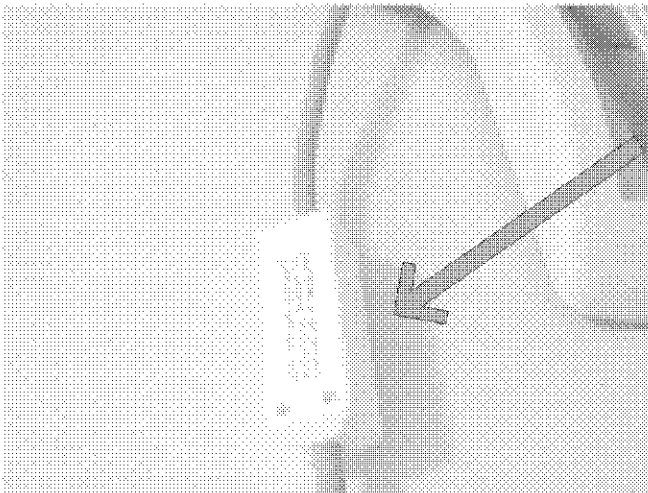
Fig. 1. The Balun Housing

Receive coil assemblies are used to investigate specific anatomies of the patient. Each assembly has been designed for prolonged safe and reliable operation. The coil assembly includes the receive coil itself, cable and cable traps. The cable traps ensure safe operation of the coil assembly via RF filtering of the signal. However, it is known that RF incidents can still occur on MR scanners, which result, in some cases, in RF or thermal burns for the patient. These incidents may be the result of unwanted RF interaction with a patient or of the heating of parts of the assembly, caused by technical failures. Thermal burns are most likely to occur from patient contact with the cable trap, indicated in Figure 1.

Specifically, the cable trap housing, which includes the cable trap for RF filtering of the MR signal is affected. These cable trap housings can be recognized most easily by its shape and warning label (see Figure 1) and by the fact that the coil assembly is produced for Philips Medical Systems by Invivo corporation (see Figure 2)

After consideration, it was decided not to replace or revise the cable traps in the installed base of these coils because the chance on malfunctioning of the coil assembly was estimated to be unlikely. This probability can be reduced further by paying more attention to the application (positioning) of the device, as instructed in the documentation supplied with the system.
