**URGENT - Field Safety Notice  
1.5T Intera and 1.5T Achieva systems**

**Risk to patient using the Synergy Flex-M / Shoulder Coil 1.5T**

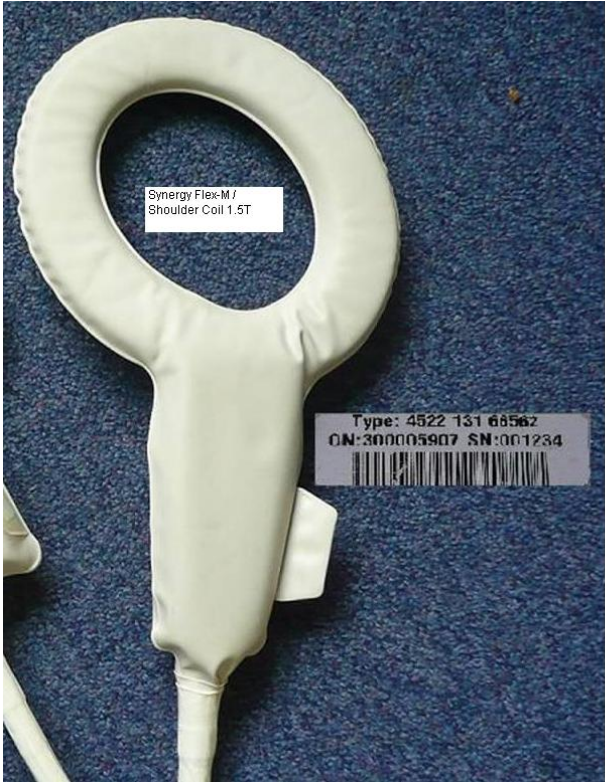
<p>The identification of the Synergy Flex-M can be found on the driver box. The 12nc of the affected systems is <b>4522-131-6656x</b></p>
