## URGENT - Field Safety Notice Eclipse 1.5T MRI System

### MR Eclipse 1.5T RF Connector Block

**MR Eclipse 1.5T RF Connector Block**

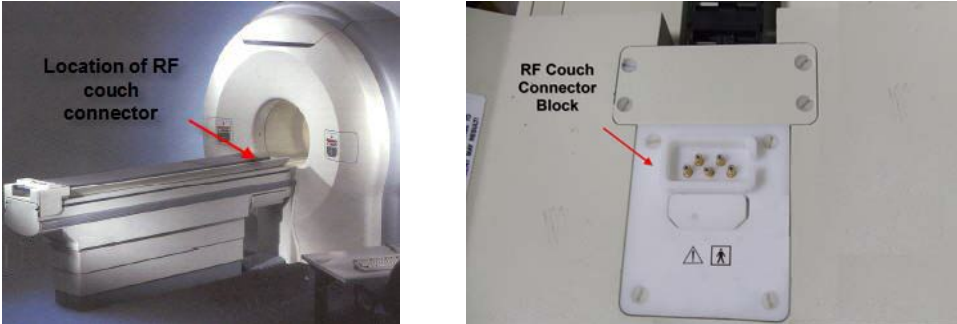
<b>AFFECTED PRODUCTS</b>	Item number: <b>453566228381</b> Catalog item: <b>781230</b> Shipped between <b>June 23, 1997 thru June 30, 2002</b>
<b>PROBLEM DESCRIPTION</b>	The RF connector block on the tabletop has the potential to smoke and ignite during scanning due to a combination of arcing of electrical components below the connector and the flame rating of the connector block material.
<b>HAZARD INVOLVED</b>	Possible injury to patient.  The potential harm would be injury to patient if flames or smoke were present. The general practice of technologists frequently checking on patient status would provide some mitigation.
<b>HOW TO IDENTIFY AFFECTED PRODUCTS</b>

<b>ACTION TO BE TAKEN BY CUSTOMER / USER</b>	Ensure to maintain frequent contact with patients during scanning and that the patient comfort kit is installed for all patient studies.
<b>ACTIONS PLANNED BY PHILIPS</b>	Beginning mid February, a Philips Field Service Technician will visit your facility to inspect your system and replace the existing part with the new RF Connector Block.
