Urgent Field Safety Notice

GE Ref: FMI # 60802

May 2011

RE: **MRU Fuse Replacement**

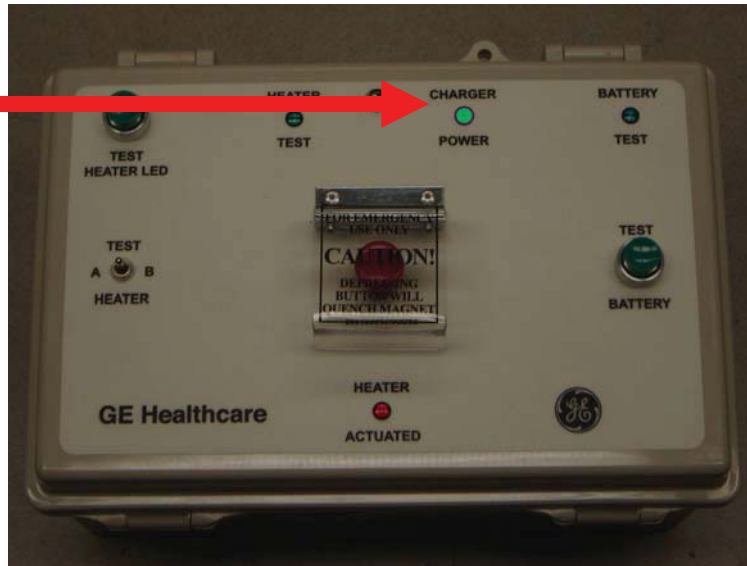
Illustration 1

5.01 Verify CHARGER POWER LED is illuminated. If this LED is illuminated the MRU fuse is functioning properly. If the CHARGER POWER LED is not illuminated immediately contact your GE Field Service representative.

Charger Power LED

Verify that the Charger Power LED is illuminated.

GE Healthcare will correct all affected systems by providing a hardware resolution at no cost to you. A GE Healthcare service representative will contact you to arrange for this correction.
