Urgent Field Safety Notice

GE Healthcare

GE Healthcare Ref: FMI 80150

RE: **GenIQ software application on Advantage Workstation (AW) or AW Server may lead to incorrect parametric values calculation when 3T datasets are invoked while using an MR system.**

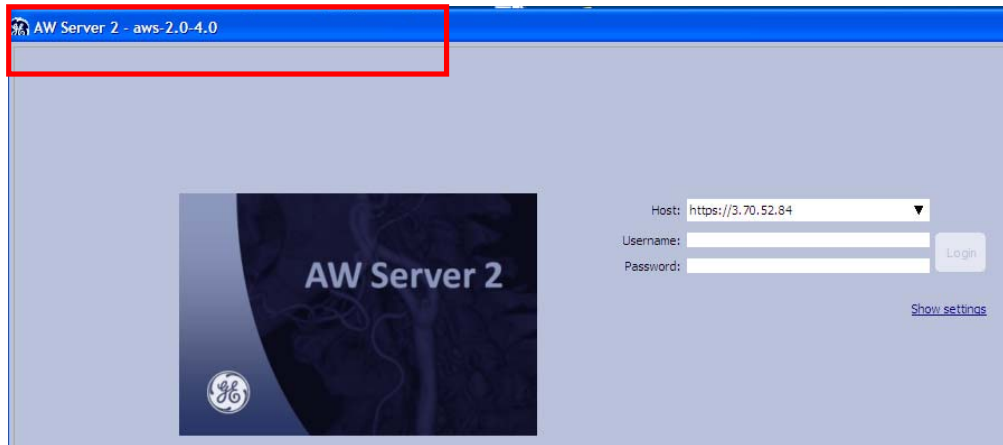
To identify which version of AW Server you are using, launch the AW Server client and verify the version in the top left corner of the log in screen (shown below with version highlighted in the red box).
