Magnetic Resonance

FSN781 00484

URGENT - Field Safety Notice Medical Device Correction

Additional fixation (grip) of the ceiling speakers of the MR system

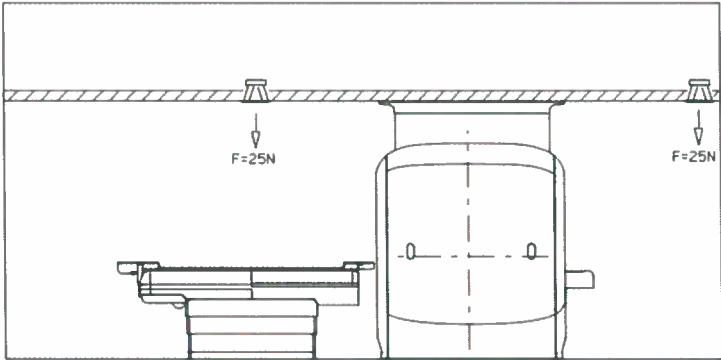
AFFECTED PRODUCTS	Intera, Omniva, Enterprise, Achieva, Achieva XR, Achieva Conversion, Panorama HFO, Ingenia, SmartPath to dStream, Multiva, Prodiva, MR-OR, MR-RT, MR-Linac, MR-Marlin systems
PROBLEM DESCRIPTION	<p>Philips MR systems are standard equipped with two ceiling speakers, positioned in the front and/or rear of the MR system. These speakers enable communication between the operator in the examination room and the patient and offer stereo music or ambient experience audio. These speakers are in most cases fixated in the suspended ceiling of the MR examination room according the Philips service instructions. The Philips Planning Reference Data (PRD) prescribes the suspended ceiling must be strong enough to hold 25 N speakers.</p> <p>However in very rare cases, due to external influences (hospital facility maintenance, water leakage, degradation of speaker fixation) during the lifetime of the MR system, the ceiling speaker(s) could fall from their position and be pulled to the MR system by the magnetic field.</p>

HAZARD INVOLVED	<p>In case the ceiling speaker or ceiling tile with speaker drops down, it will get pulled to the MR system by the magnetic field. This potentially can result in:</p> <ul style="list-style-type: none"> - serious injury to a patient, operator or other persons in the examination room - damage to the MR system, e.g. covers <p>The severity of such event depends on where, how and if the ceiling speaker or tile hits a person or system.</p>
HOW TO IDENTIFY AFFECTED PRODUCTS	<p>All MR systems listed above have been delivered with two Philips speakers. The customer can visually check if these ceiling speakers are mounted in the ceiling.</p> <p>Note: At some customers, ceiling speakers are mounted to the wall with a wall mounting box, which does not present a similar risk. Therefore, wall-mounted speakers are out of scope for this notification.</p>

ACTION TO BE TAKEN BY CUSTOMER / USER	<p>Following checks/actions by the customer are recommended:</p> <ul style="list-style-type: none"> - Check if the speakers are mounted in the ceiling. - Visually check for signs of fixation degradation: e.g. water leakage, color changes of ceiling tiles, poorly positioned tiles. - In case of suspected insufficient fixation, do not correct the fixation yourself, but immediately contact your local Service/Philips representative.
