To all users of the following software products: syngo.via RT Image Suite

with NUMARIS X A11 and A20 software

Customer Safety Advisory Notice MR020/20/S

Subject: Potential incorrect geometry in resulting Synthetic CT images created by the software option "Synthetic CT" of syngo.via RT Image Suite when using input MR images

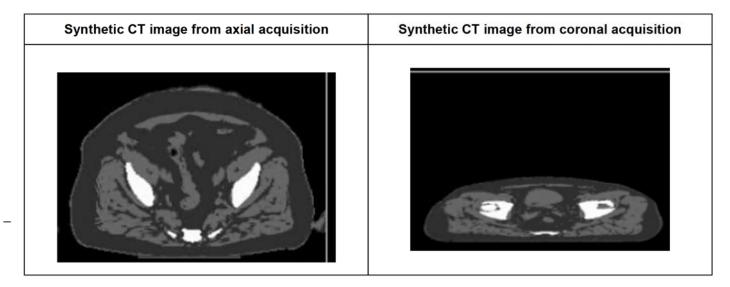
If the user modifies for any reason (e.g. reduction of artifacts) the original image orientation of a standard MR protocol to acquire images in a different orientation for further processing in "Synthetic CT", the software does not recognize the adapted acquisition plane. This may result in images with wrong geometry. When this distortion remains unnoticed and the images are subsequently exported to a treatment planning system (TPS), it cannot be excluded that this results in an incorrect calculated radiation treatment plan. The occurance of this case is very unlikely and has never been reported so far.

An example of a visibly distorted image is shown in Fig. 1.

Fig. 1: Comparison of Synthetic CT image calculated from axial acquisition to Synthetic CT image calculated from coronal direction.

- 1. Use MR data acquired in axial orientation as input for Synthetic CT calculation only.
- 2. Use protocols validated by Siemens Healthineers only.
- 3. In any case, always perform a pretreatment verification to compare the actual treatment position with the target position.

The described issue will be solved with a service pack for software versions

- Syngo.via server: syngo.via VB30 with update SY039/20/S and syngo.via VB40 with SY040/20/S
- MAGNETOM systems: NUMARIS X A20A with service pack 04 provided with MR021/20/S.
