Customer Safety Advisory Notice MR072/23/S

SAFETY ADVISORY NOTICE

Customer Information about possible artifacts from over-ear headphones during head examinations

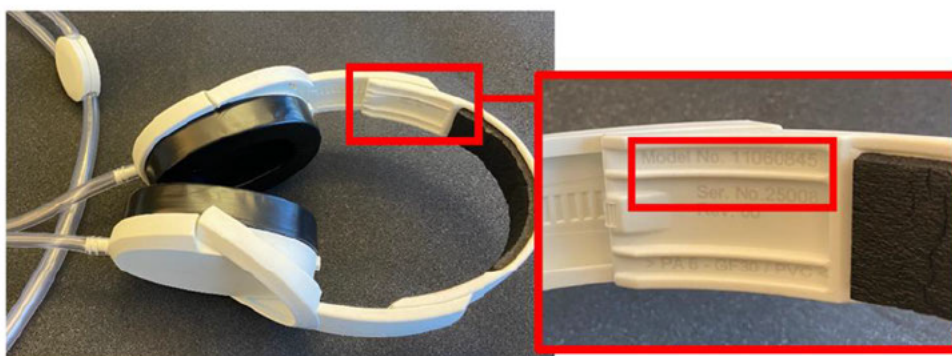
Figure 1: Location of model number and serial number on over-ear headphones

- Check the model number and serial number of your over-ear headphones. See *Figure 1* for their location on the over-ear headphones. If the model number is not identical or the serial number is outside the stated range (7981 – 32200), they are not affected.

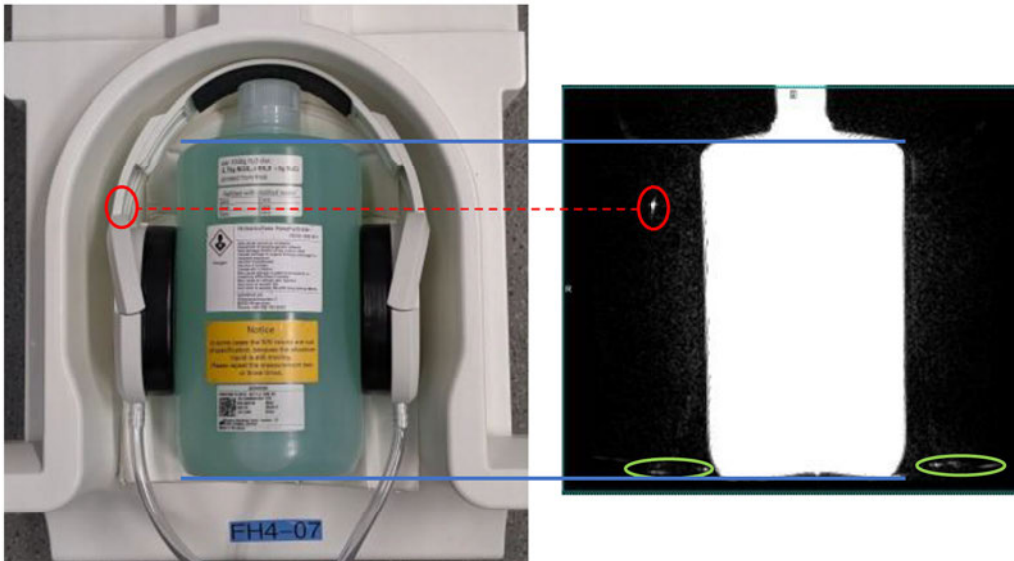
Figure 2

In some cases, when lubricating grease is present within the headband of the over-ear headphones, it may cause visible, dot- or line-shaped, fat-isointense artifacts during **head examinations only**. These potential artifacts depend on the position of the headband, the amount of lubricating grease, as well as the sequence parameters used. This issue does not impact scans of other body regions.

Siemens Healthineers became aware of this issue during post market surveillance. The root cause has been identified as a manufacturing processing error.

Left side: correct setup of phantom bottle and headphones in head coil

Right side: Example of signal from lubricating grease can be seen outside the phantom, marked with a red circle. The artifacts must be on the same height as the potential affected headbands of the headphone.

Please note: MR imaging often shows artifacts with phantom bottles in this extreme windowing e.g., at the top and/or bottom of the phantom. These artifacts are marked with green circles in the above example and can be ignored.

- **If artifacts are visible** during the described phantom measurements, your over-ear headphones are affected and must not be used for head examinations. In this case, please use the built-in loudspeaker in the scanner for patient communication or, if available, in-ear headphones which are also not affected by the described issue.

Siemens Healthineers will correct the issue by exchanging the headband of the affected over-ear headphones at customer sites with the field update MR073/23/S. This replacement program will start in October 2023. With the exchange of the headband the root cause is eliminated.
