URGENT Field Safety Notice

Multiva 1.5T

Gradient Coil component failure may act as a heat source with potential to produce smoke and/or fire.

October 23, 2023

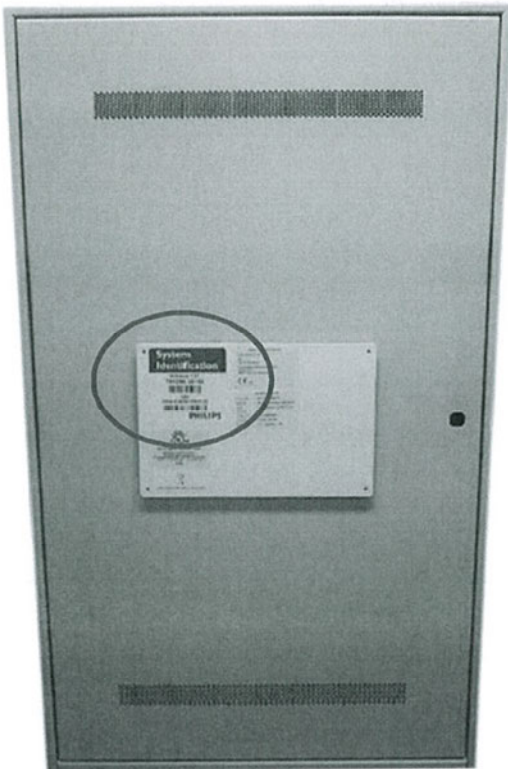
Figure 2: Front door of gMDU

- 3.1. Enter the Technical Room
- 3.2. Locate the general Mains Distribution Unit (gMDU) and Liquid cooling cabinet (LCC)
- 3.3. The system label is located on the front door of the gMDU (see figure 2) or LCC (see figure 3)
- 3.4. Locate the serial number on the system identification label (see figure 4)

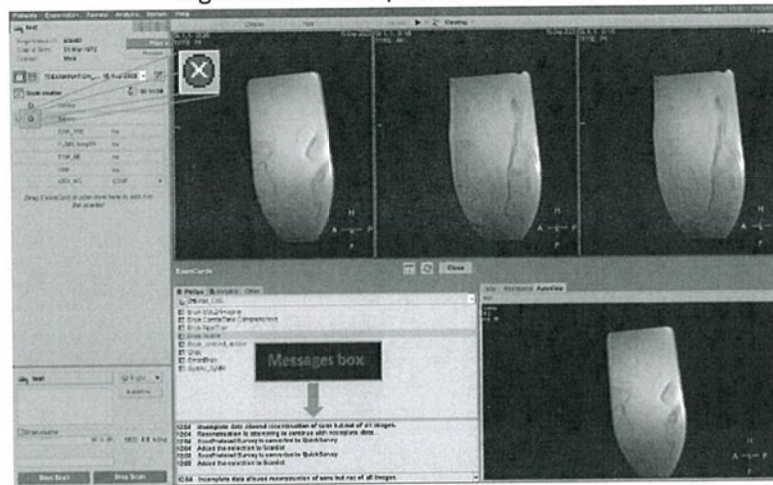
Figure 6. UI example SW Version R5.

- 4.3. When scan aborts occur the symbol is shown and applicable messages are presented in the message box (see Figure 6 examples)
 - 4.3.1. Check the status of the error messages in the User Interface (UI) screen. Click to expand the message box in case previous messages are hidden, see orange box in Figure 6 below. If possible, correct the issue that is relevant to the error shown, and continue scanning, for example:

- 4.3.2. If, after a scan abort, one of the following conditions occur five times in a row stop scanning immediately and contact Philips Service to describe the problem:

- If there is no error message in the message box
 - If the error message meaning is not clear
- 4.3.3. If the error message “Gradient amplifier Rack Fault” is received two times in a row, or if the error message “Gradient amplifier Rack Fault” is preceded or followed by an aborted scan with no message, then stop scanning immediately and contact Philips Service to describe the problem.

- 4.3.4. If you encounter any of these conditions described in 4.3.2 or 4.3.3 do not attempt any additional/further scans, including without limitation do not attempt any phantom scanning until your system has been checked and released by a Philips Service representative.

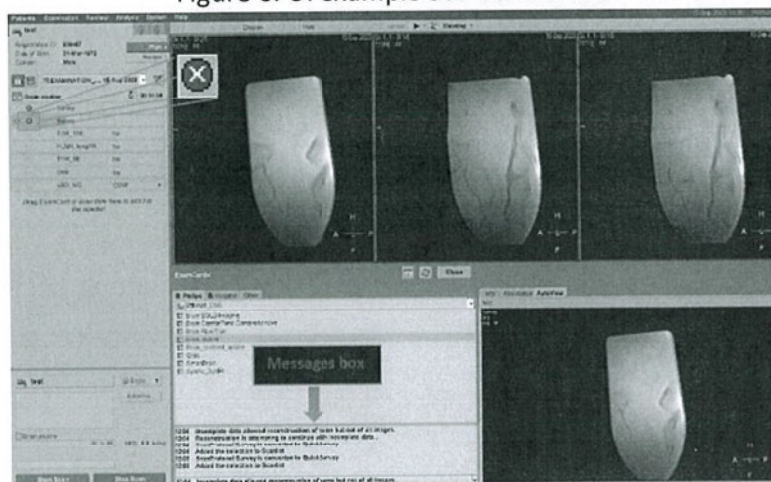
Figure 6. UI example SW Version R5.

- 4.3.1. Check the status of the error messages in the User Interface (UI) screen. Click to expand the message box in case previous messages are hidden, see orange box in Figure 6 below. If possible, correct the issue that is relevant to the error shown and continue scanning, for example:

- 4.3.2. If, after a scan abort, one of the following conditions occur five times in a row stop scanning immediately and contact Philips Service to describe the problem:
 - If there is no error message in the message box
 - If the error message meaning is not clear
- 4.3.3. If the error message “Gradient amplifier Rack Fault” is received two times in a row, or if the error message “Gradient amplifier Rack Fault” is preceded or followed by an aborted scan with no message, then stop scanning immediately and contact Philips Service to describe the problem.

- 4.3.4. If you encounter any of these conditions described in 4.3.2 or 4.3.3 do not attempt any additional/further scans, including without limitation do not attempt any phantom scanning until your system has been checked and released by a Philips Service representative.
