URGENT: Field Safety Notice

FSCA identifier: Product Field Action RA2013-123
Type of Action: Field Safety Corrective Action
Description: ADM[®]/MDM[®] Ball Impactor Tip and ADM[®] Rim Impactor Tip
Catalog #: 1235-0-013, 1235-0-014
Lot #: All

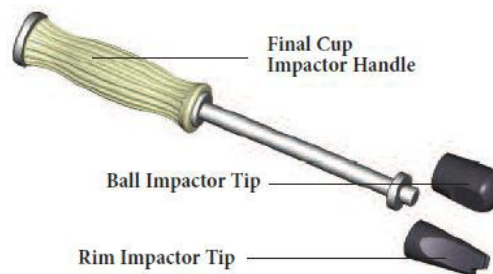
On September 19th, Stryker[®] Orthopaedics (“Stryker[®]”) initiated a voluntary Product Correction for the ADM/MDM Ball Impactor Tip and ADM Rim Impactor Tip, instruments associated with Stryker’s Anatomic Dual Mobility (ADM) and/or the Modular Dual Mobility (MDM) Acetabular Systems. Stryker has received complaints associated with cracks and/or fracture of the Ball Impactor Tip and Rim Impactor Tip instruments. Images of each are provided below.

1. Cracked and/or fractured Ball Impactor Tip/Rim Impactor Tip.
2. Loose fragments from Ball Impactor Tip/Rim Impactor Tip.
3. Insufficient locking strength of MDM liner (Ball Impactor Tip only).

The surgical protocols associated with the ADM (ref. LSP64) and MDM (ref. LSP73) Systems have been updated to recommend use of the slotted mallet (cat. no. 1120-1000) to impact the impactor handle when using the tips and to emphasize that the Ball Impactor Tips and Rim Impactor Tips should be inspected for deformation and cracks before use. See attached Product Correction Bulletin for specific details.
