## **Urgent Field Safety Notice (FSN)**

**Product Name:** GLOBAL APG+ 2.5mm Breakaway Guide Pin

**Date:** April 2014

**FSCA Identifier:** DVA-108588

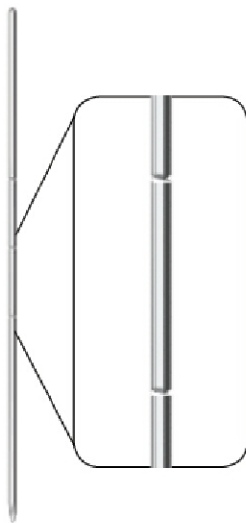
DePuy Orthopaedics, Inc. is issuing a voluntary device correction for the GLOBAL APG+ 2.5mm Breakaway Guide Pin (single-use shoulder instrument). The Field Safety Notice is being issued to inform users about the possibility of the pin breaking and potentially being left in the patient. Information regarding the affected instrument's use will be included in the following surgical techniques:

Figure 1: Image of GLOBAL APG+ 2.5mm Breakaway Guide Pin from the GLOBAL® APG+ Design Rationale and Surgical Technique

The guide pin is scored in three locations, which allows the surgeon to select a desired pin length. The single-use shoulder instrument is made from 316L Stainless Steel.

- “The grooves on the 2.5mm Breakaway Guide Pin are exclusively used for the breakaway feature and are not intended to indicate the depth to which the pin should be inserted.”
- “The pin is designed to break at the grooves. Be aware that it may break unintentionally if subjected to too much bending force.”

- “After use of the guide pin is complete, confirm that all sections (totaling the full length of the original, unbroken pin) have been removed.”
