Subject: **URGENT FIELD SAFETY NOTICE - CORRECTION**

FSCA Identifier: 9617840-05-06-2015-001-R ; ZFA-2015-33

Affected Product: Tibial Alignment Guide – iAssist Knee System

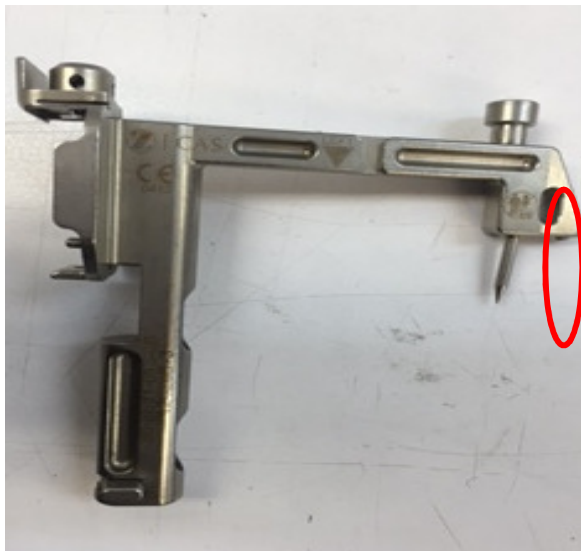
Based upon complaint investigation, Zimmer CAS has determined that the potential exists for the spikes on the iASSIST Tibial Alignment Guide to bend or break during insertion or extraction from the tibia during use. The bending or breakage of the spikes is due to a stress riser at the junction of the spike and the main body of the instrument in combination with the presence of repeated high cyclic bending stresses from the impaction method utilized. These stresses are significantly increased when the proper steps of the surgical technique are not followed. Although unlikely, if a spike breaks and goes unobserved, there is the possibility of a spike being left in the surgical site. There have not been any complaints for this instrument associated with a spike being left in a patient. Product manufactured after May 2014 is not affected as they have a different assembly method of the spike that reduces the risk of fatigue. The affected devices were distributed in the EU from December 2012 through July 2014.

Figure 1: Missing spike

1. Please carefully review this letter and ensure users of the iASSIST Knee system at your facility have been informed of this notice.
2. During use, to minimize the chances of bending or breakage, please follow the iASSIST Surgical Knee technique, as highlighted below (Reference 97-9001-101-00).
3. Inspect the device before and immediately after use to confirm that the spikes are not bent or broken. Please keep Zimmer informed of any adverse events associated with this device or any other Zimmer product. Adverse events may be reported to Zimmer at cas-support@zimmercas.com along with the return any affected device(s).
4. Please complete and sign the attached Certificate of Acknowledgment and return it to fieldaction.emea@zimmer.com.

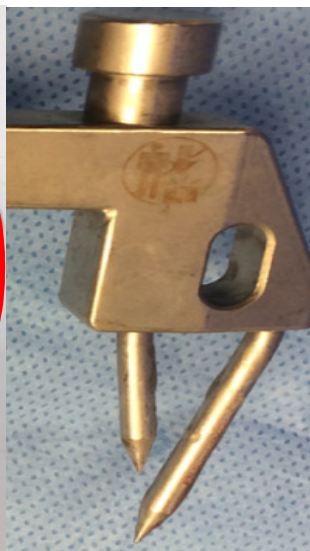
Figure 2: Bent spike
