28th October 2016

Subject: **URGENT FIELD SAFETY NOTICE**

Affected Product:

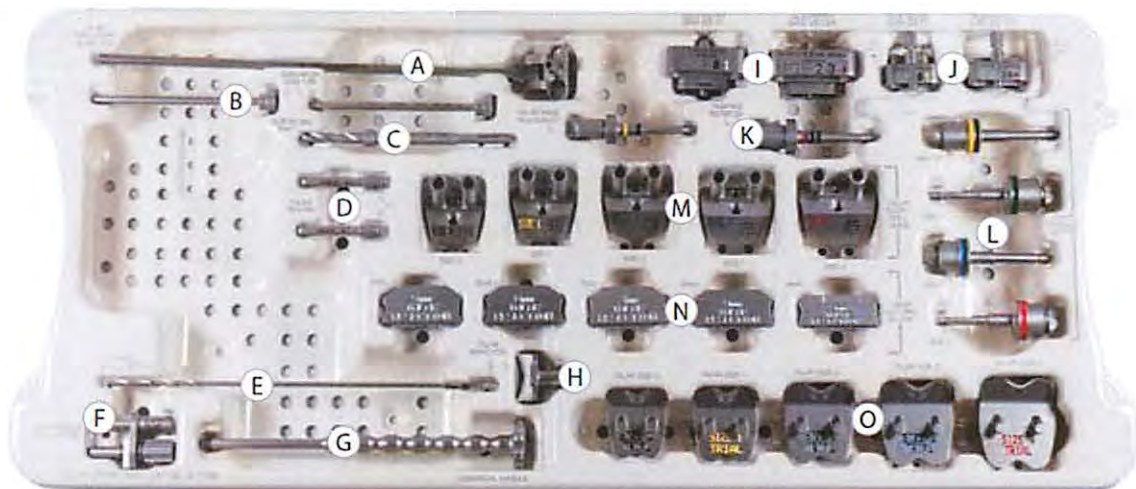
Talar Instrument Tray - Top

Description	Item Number	Affected Serial or Lot Numbers	Tray Position
Rebalance Talar Ant Router Guide Size 0/1	407775	FS72117	I
Rebalance Talar Sulcus Guide Size 0/1	407776	FS72400	J
Rebalance Talar Sulcus Guide Size 0/1	407776	FS71394	J
Rebalance Talar Sulcus Guide Size 0/1	407776	FS69451	J
Rebalance Talar Ant Router Guide Size 2/3/4	407777	FS72119	I
Rebalance Talar Ant Router Guide Size 2/3/4	407777	FS71831	I
Rebalance Talar Ant Router Guide Size 2/3/4	407777	FS71397	I
Rebalance Talar Sulcus Guide Size 2/3/4	407778	FS72403	J
Rebalance Talar Sulcus Guide Size 2/3/4	407778	FS71400	J
Rebalance Talar Drill Guide Align Rod	407760	FS74140	A
Rebalance Talar Drill Guide Align Rod	407760	FS73505	A

This notice is to inform you of an URGENT FIELD SAFETY CORRECTIVE ACTION that has been initiated by Biomet UK Ltd which involves the Rebalance instruments referenced above. Our records show that these instruments may have been distributed to your hospital as a single instrument and/or as part of the instrument set contained in kit number 407798. We are requesting that you immediately locate and discontinue use of the instruments with the above item/lot numbers.

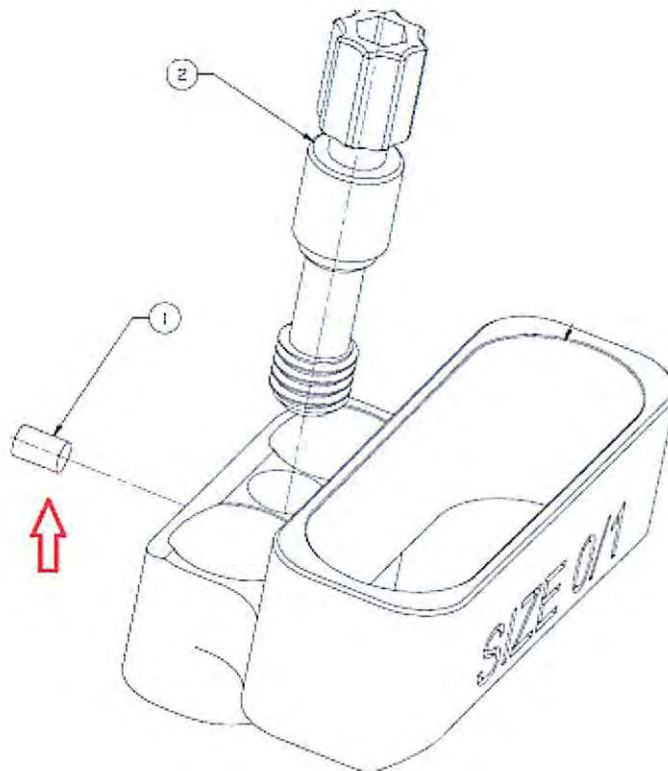
Example Item shown below

Biomet UK Ltd has initiated this action following an investigation that has revealed that it is possible that the pin (1) could become loose and disengage from the instrument.

Immediate health consequences (injuries or illness) that may result from use of or exposure to the device issue.	Most Probable	Worst Case
	If the laser welded pin is loose and is detected to have fallen into the patient and is removed by the surgeon, then no immediate health consequence is expected other than a minor surgical delay.	OR staff recognize that an attachment screw is missing prior to surgery and surgery is then cancelled. This may result in the patient needing to be subjected to second round of anesthesia.
Long range health consequences (injuries or illness) that may result from use of or exposure to the device issue.	Most Probable	Worst Case
	If pin is not detected to have fallen into the patient and is left within patient after surgical closure, then the pin could enter joint space and cause an increase in polyethylene wear, which could lead to a long term revision surgery Also if the attachment screw is loose then could lead to early loosening and revision due to inaccurate bone resections.	If pin is not detected to have fallen into the patient and is left within patient after surgical closure, then the pin could enter joint space and cause an increase in polyethylene wear, which could lead to a long term revision surgery Also if the attachment screw is loose then could lead to early loosening and revision due to inaccurate bone resections.

1. Review this notification and ensure affected personnel are aware of the contents.
2. Assist your Zimmer Biomet sales representative quarantine all affected product.
3. Your Zimmer Biomet sales representative will remove the affected product from your facility.
4. Complete Attachment 1 – Certificate of Acknowledgement.
 - a. Return a digital copy to fielddaction.uk@zimmerbiomet.com
 - b. Retain a copy of the Acknowledgement Form within your records in the event of a compliance audit of your facilities documentation.
5. If after reviewing this Urgent Field Safety Notice you have further questions or concerns please contact your local Zimmer Biomet representative.
