Subject: **URGENT MEDICAL DEVICE FIELD SAFETY NOTICE – REMOVAL**

Reference: **ZFA2019-00056**

Affected Product: GTS Trunnion Rasp

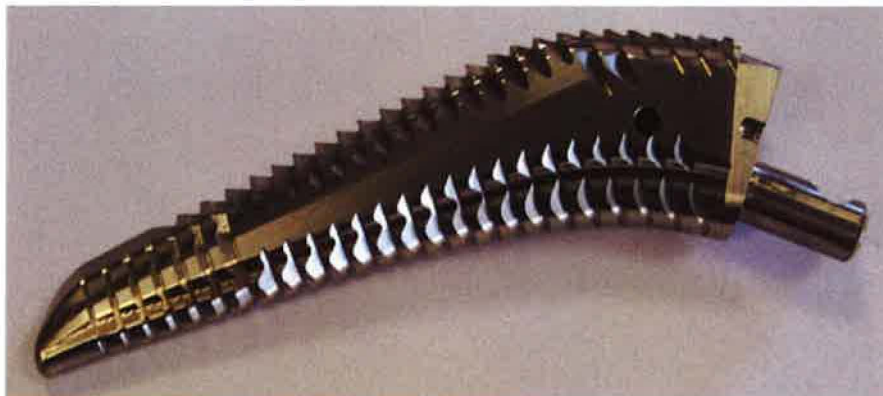
*View of the GTS Rasp*

Certain fractures of GTS Trunion Rasp were identified through complaints, with no patient impact associated. Investigations demonstrated that the issue might be linked with a specific raw material. Therefore, GTS rasps that are not included in the scope of this Field Safety Corrective Action are not impacted by this issue and can be used.

As a precautionary measure Biomet France Sarl is conducting a medical device Field Safety Corrective Action (removal) for specific lots of the GTS Rasps as per scope indicated above.

1. Review this notification and ensure that affected personnel are aware of the contents.
2. If you have affected instruments at your facility, assist your Zimmer Biomet sales representative and quarantine all affected instruments. Your Zimmer Biomet sales representative will remove the affected instruments from your facility.
3. Complete **Attachment 1 – Certificate of Acknowledgement** and send to [fielddaction.emea@zimmerbiomet.com](mailto:fielddaction.emea@zimmerbiomet.com). This form must be returned even if you do not have affected products at your facility.
4. Retain a copy of the acknowledgement form with your field action records in the event of a compliance audit of your facility's documentation.
5. If you have further questions or concerns after reviewing this notice, please contact your Zimmer Biomet representative.
