Urgent Field Safety Notice

30/40/50 CC IAB Catheters

30/40/50 CC IAB Volume Connectors

PRODUCT RECALL

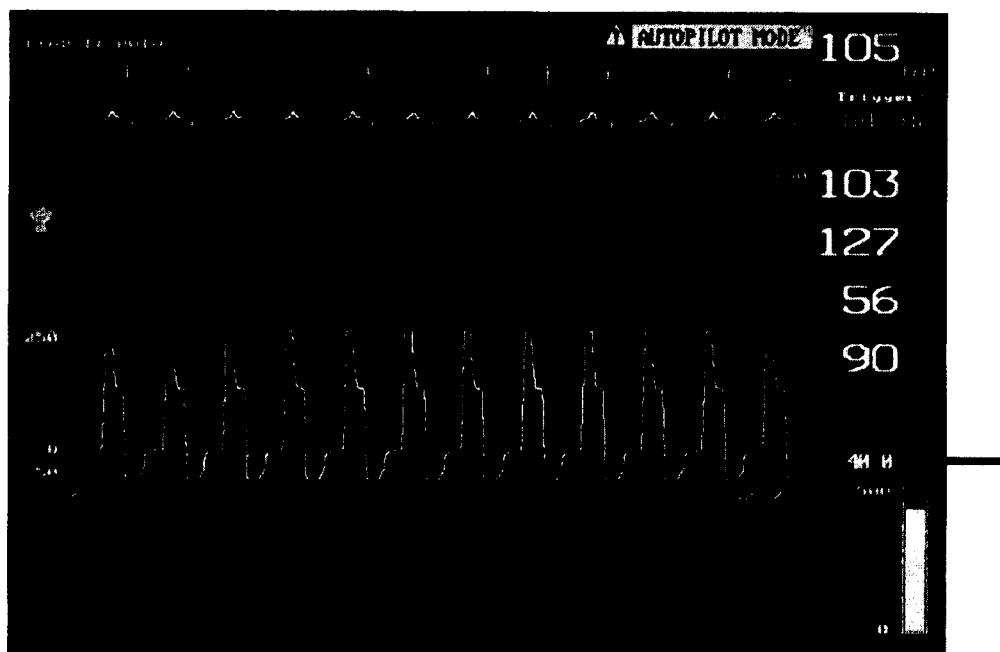
1. As stated in the Operator's Manual (See pages: 5-4 to 5-11 and 6-4 for ACAT1; 5-3 to 5-11 and 6-13 for AutoCAT 2 rev.2.21 and 5-3 to 5-11 and 6-13 for AutoCAT 2 rev 2.23.) this issue can be recognized immediately by verifying the VOLUME SETTING displayed on the screen of the ACAT 1 Plus and AutoCAT 2 Series IABP Console. The currently set volume of the IAB balloon pump catheter is shown in the Lower Right Area of the display, below the Hemodynamic values and above the HE tank bar graph. As soon as the IAB Volume connector is securely connected, the volume of the corresponding IAB catheter and connector should be properly displayed in the area shown. The IAB volume is also printed on the recorder strip.

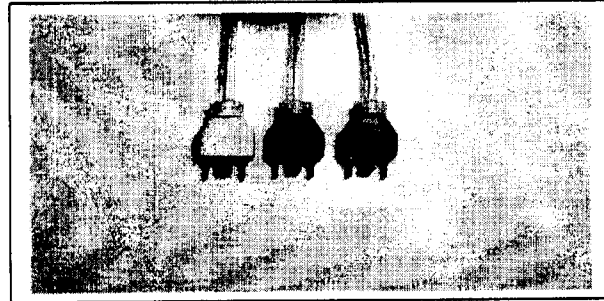
3. **Verify** that after the IAB connector of the IAB pump tubing assembly is attached to the IABP console, the volume setting is correct for the corresponding connector that is listed below. The volume settings are as follows for the each color coded connector below:

- a. **White Connectors: 30cc**
- b. **Blue Connectors: 40 cc**
- c. **Orange Connectors: 50 cc**

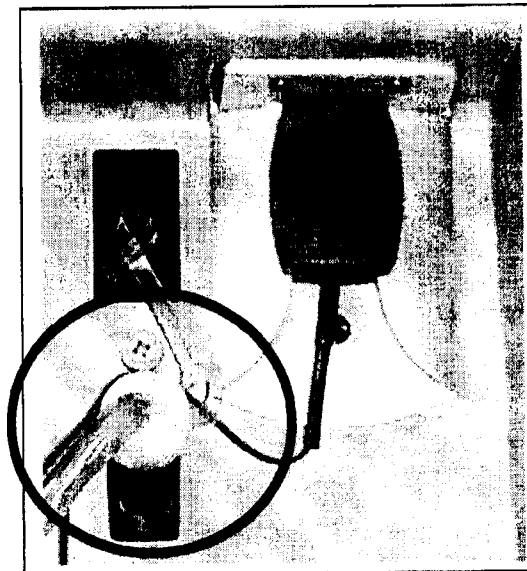
5. If the volume is NOT properly displayed and reads 2.5cc on the AutoCAT 2 Series or 5.0cc on the ACAT 1 Series;
- a. **Disconnect and Reconnect the IAB Pump Tubing Assembly connector** making sure the IAB pump tubing assembly connector is fully seated in the receptacle.

- b. Verify the IAB volume setting on the IABP. If it is showing the correct volume, no further action is required.
6. If the IAB volume is still **INCORRECT**, you should replace the IAB Pump Tubing assembly with a tubing assembly of the same volume size.
 - a. **DISCONNECT** the IAB pump tubing assembly at the QUICK CONNECT on the balloon.
 - b. **REPLACE** with another appropriate size pump tubing assembly. Pump Tubing Assembly may be ordered from Arrow using 30cc (Part Number IAK-02696), 40cc (Part Number IAK-02695), and 50cc (Part Number IAK-02693).
 - c. **RECONNECT** to IABP and verify IAB volume setting is correct, as described above.
