Urgent Field Safety Notice

multiFiltratePRO devices (M205001) – blood leak detection

Date: February 20th, 2017

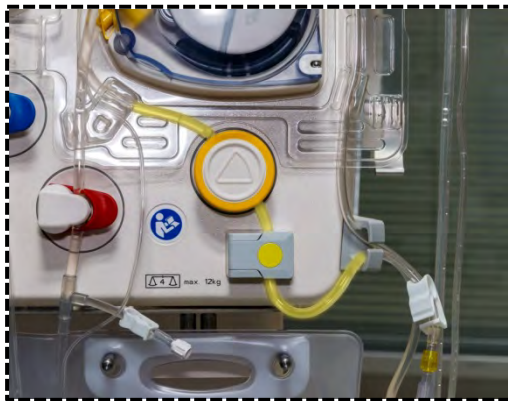
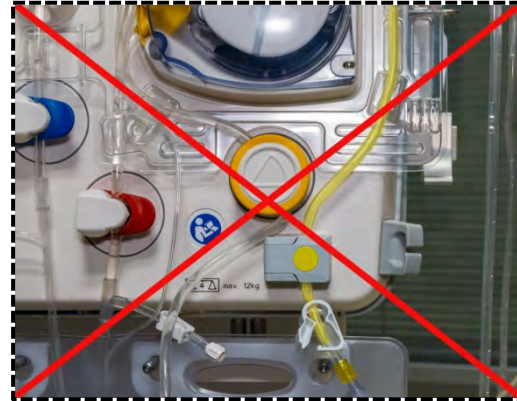
The BLD door is more likely to open inadvertently if tubes are inserted incorrectly (e.g., incorrect segment of the filtrate tubing system). Therefore, we strongly advise routing the tube in accordance with the requirements in the Instructions for Use and on the screen.

The tube emerging from the yellow positioner must be inserted into the pressure measurement unit with the filtrate pressure dome, routed through the BLD, and then inserted into the line holder (this includes checking the catch mechanism on the BLD door). See the illustrations below:

Furthermore, we strongly advise regular checks to ensure that the catch mechanism of the BLD door is operating **fully** and **correctly**. In particular, this must be done if the tubing system has been moved; for example, during a bag change.
