### URGENT FIELD SAFETY NOTICE

Product Name: **Alaris™ / Asena™ GS, GH, CC, TIVA, PK, Enteral Syringe Pump**  
Product codes with prefix (all variants): **8001, 8002, 8003, 8004, 8005, 8007**  
FSCA Identifier: **RA-2018-03-01**  
Date: **May 2018**  
Type of Action: **Field Safety Notice**

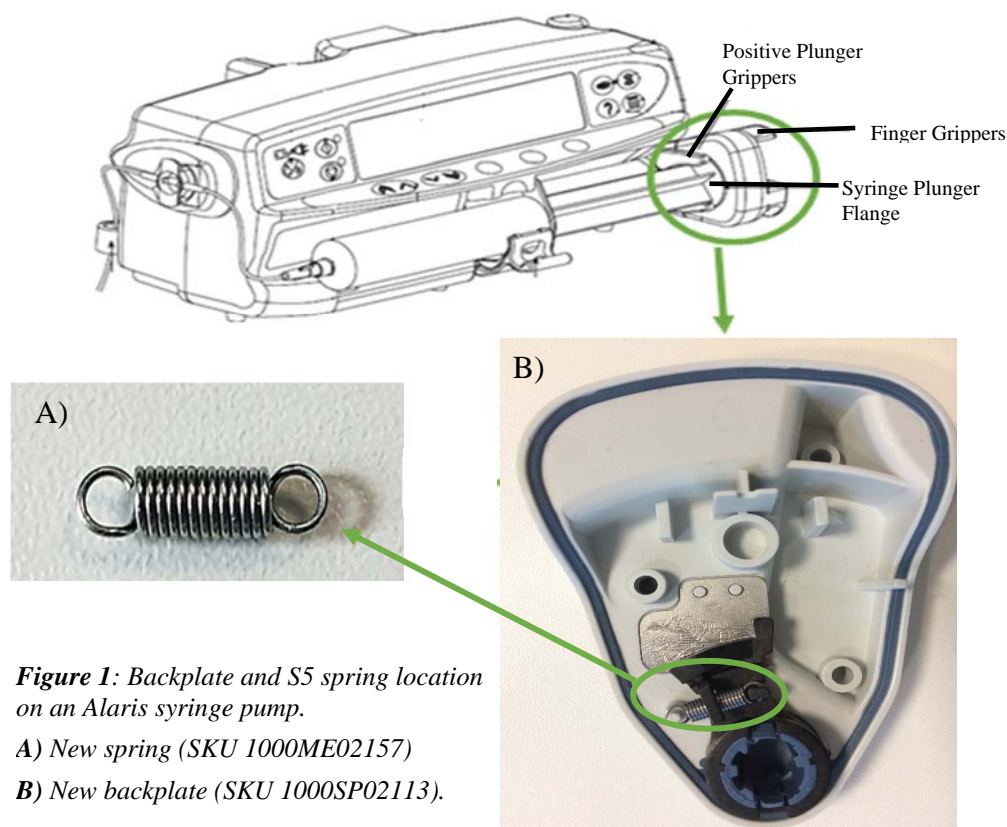
The S5 spring is located on the back-plate of the syringe plunger holder and ensures that the syringe plunger flange sits tightly between the positive plunger gripper and the back-plate.

BD has identified that the gripper plate actuating spring (S5), can break and may prevent the gripper fingers from securing the syringe plunger within the plunger holder mechanism which causes a small gap between the syringe plunger flange and the syringe drive mechanism. See Figure 1.

In some circumstances the gap between the syringe plunger flange and back-plate may result in a clinically significant over infusion. Neonatal and paediatric patients, or those receiving critical drugs, at low infusion rates, would be considered to be the most at risk if small volumes of fluids reach the patient due to siphoning.

1. Over infusion due to syringe siphoning of <1mL (0.37ml for 5mL syringes to 0.87ml for 50mL syringes) volume of fluid.
2. Delayed start of infusion when the system detects the syringe plunger flange is not in contact with the back-plate and will generate a Check Syringe alarm.

- 1) Please acknowledge receipt of this Field Safety Notice (FSN) by completing and returning the Acknowledgement Form (Appendix I). Using the Acknowledgement Form, please confirm your preferred option for remediation. Please note that if you choose option 2 below, the FSCA acknowledgement form needs to be returned to BD prior to ordering the backplate assembly part number SKU 1000SP02113.

- a. **OPTION 1:** BD to carry out the backplate assembly replacement.

- b. **OPTION 2:** The customer to carry out the backplate assembly replacement.
