URGENT FIELD SAFETY NOTICE

**Edwards Lifesciences Commander Delivery System
Models 9610TF20, 9610TF23, 9610TF26, 9610TF29
Reference: FCA-123**

Balloon Tears - ACTION REQUIRED

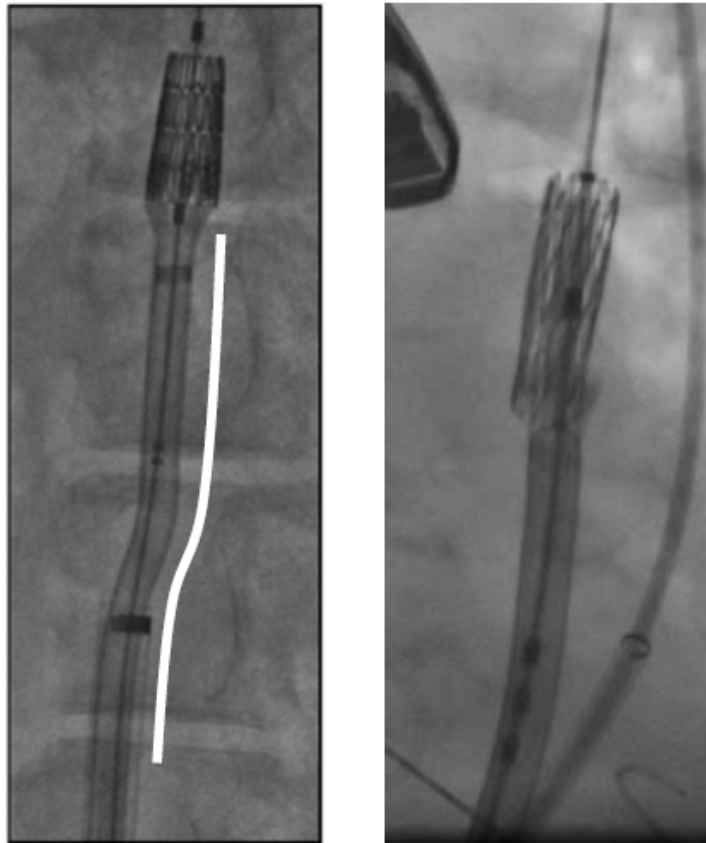
A thorough investigation of these reports concluded balloon tears typically occur when there is significant tension in the delivery system during valve alignment. Tension can be

encountered if valve alignment occurs in a non-straight section of the vasculature or if the balloon is not adequately evacuated during device preparation.

Figure 1 illustrates instances of compression/ tension in the system during the procedure:

Figure 1: Delivery system flex shaft compression (Left) and valve diving (Right).

- Ensure there is no residual fluid left in the balloon during preparation and avoid overfilling the balloon during de-airing to prevent potential valve alignment difficulty.
- Execute valve alignment in a straight section of the aorta. Utilizing alternate fluoroscopic views may help with assessing curvature of the anatomy.
- If excessive difficulty is encountered when performing valve alignment, this may be an indication that alignment is being attempted in a non-straight section of the vasculature where alignment may not be safely achieved. In these cases, repositioning the delivery system to a different straight section of the aorta and relieving compression (or tension) in the system will be necessary (see Figure 1).

If manoeuvres are not successful and severe difficulty is still encountered, discontinue attempts to align the valve in order to prevent device damage and remove the system as a single unit while maintaining guidewire position.
