Your reference:
Our reference: FSN 2019-05-22 AS/SK

Date: May 22, 2019

Field Safety Notice

Connection Lead SP (12V) for Infusomat Space, Infusomat Space P and Perfusor Space

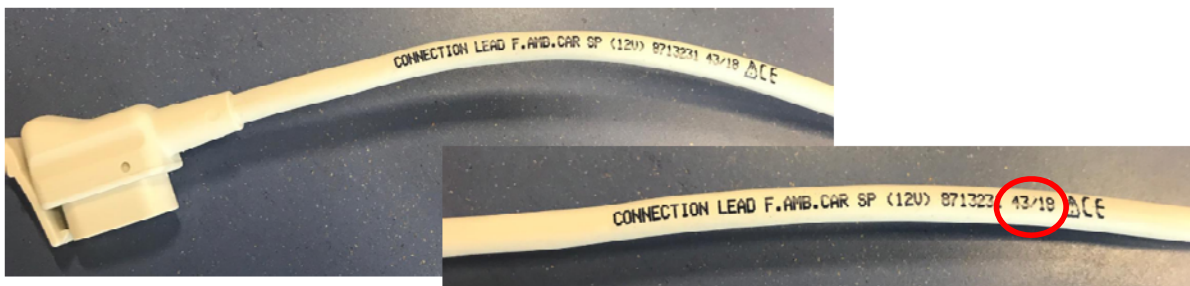
Figure 2 Indication of production date

Affected Connection Leads have been manufactured by our supplier in the period from February 2019 until May 2019. The production date is indicated as week and year (WW/YY), and is specified on the pump connector ending of the cable (see figure 2 below). The affected Connection Leads were produced between **CW 07/19 and CW 16/19**.
