15th January 2019

URGENT: FIELD SAFETY NOTICE – MMS-19-1572

T34™ and T34L™ (T60™) Ambulatory Syringe Pumps

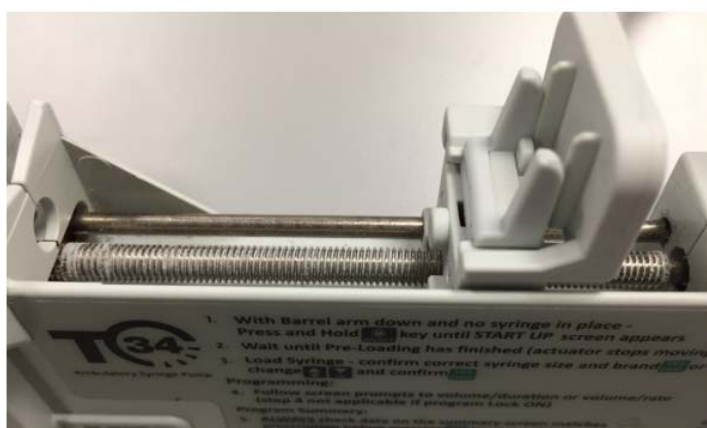
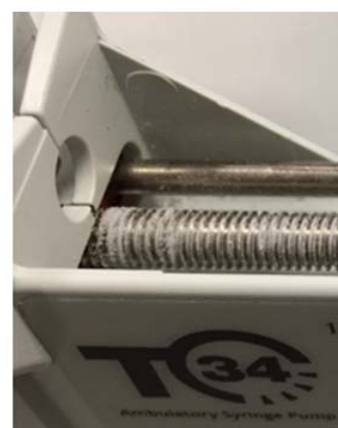
The issue can be observed when the actuator does not move when the lead screw is rotating, resulting in potentially no pressure on syringe plunger to deliver the syringe contents. The cause of this issue is the actuator nut being worn enough to stop or lose traction on the lead screw due to irregular coating of the lead screw. The “wear / tear” effect can be visually observed as the lead screw is progressively wearing the plastic actuator nut overtime, leaving white plastic debris along the lead screw (see Figure 1 below).

Figure 1: Lead Screw & white plastic debris

BD/CME has revised the Directions for Use (DFU) to include specific instructions for Users to check for plastic white debris on the lead screw during pump set up (Appendix 1). Also, BD/CME has updated the Technical Service Manual (TSM) instructions outlining changes to the maintenance and repair processes to check for plastic white debris on the lead screw and to preventively change the leadscrew and/or motor block assembly where necessary. The pump has to be checked **prior each use for plastic white debris**. Users responsible for pump set-up need to doublecheck that the infusion rate and amount was as prescribed, due to the fact that the pumps will **not alarm** the user in case of underinfusion.

Inspect the lead screw prior to use (See 3.2 Pump Description, item 4). If there is white plastic debris on the lead screw, this is an indication of wear on the syringe mechanism. Therefore, discontinue use and send the pump for service.
