URGENT MEDICAL DEVICE FIELD SAFETY NOTICE

Medfusion™ 3500 and 4000 Syringe Infusion Pumps

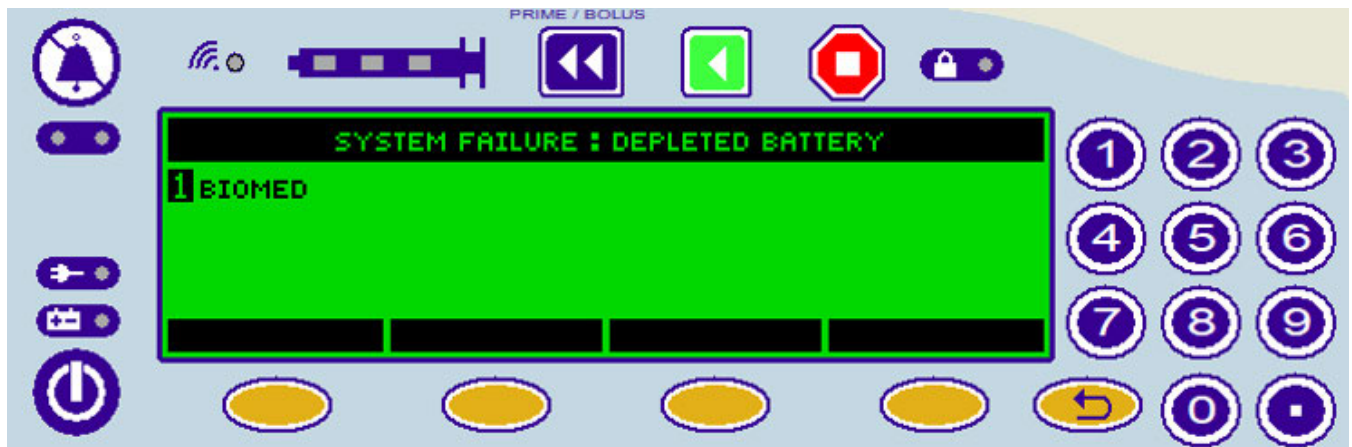
If this situation occurs while the pump is connected to AC power, the pump will display a System Advisory: Battery Communication Timeout alarm. The Battery Communication Timeout (BCT) alarm will occur once and ongoing infusions will continue.

If the pump is unplugged and running on battery, the pump assumes the battery is depleted and sounds an unexpected Depleted Battery (DB) alarm, as shown in the following figure (Figure 1), without the Primary Low Battery alarm being triggered. Even if the battery contains sufficient charge capacity, any ongoing infusion will be interrupted.

Figure 1: System Failure: Depleted Battery Alarm

If the pump is running on battery power and a Battery Communication Timeout (BCT) alarm occurs, the pump assumes the battery is depleted and issues an unexpected Depleted Battery alarm. If the pump is infusing, interruption or delay of therapy may occur as a result. Depending on the patient's condition, the type of medication being delivered, the length of time the therapy is interrupted, and the level of clinical supervision, prolonged symptoms and a potentially life-threatening situation could occur. **To date, Smiths Medical has received reports of four serious injuries related to this issue.**

2. Unless your facility informs you that pump wireless communications are disabled, **be aware that unexpected Depleted Battery alarms may occur** when batteries should have sufficient charge capacity **and that these alarms will stop the infusion.**

3. Unless your facility informs you that they disabled pump wireless communications, **keep the pumps plugged into AC power whenever possible.**
 4. **If possible, do not use the pumps if they are disconnected from AC power.** If you must use the device on battery power, for example, when transporting a patient who has critical medications infusing, **bring backup pumps** to use in case this issue occurs. **Be aware that this issue may occur on backup pumps as well.** Plug the pumps back into AC power as soon as possible.

5. If this issue occurs while a pump is on battery power:
 - Press the Power button to turn the pump off.
 - Plug in the AC power cord, and turn the pump on. You can resume the infusion from the point when the alarm interrupted the infusion by following these steps:

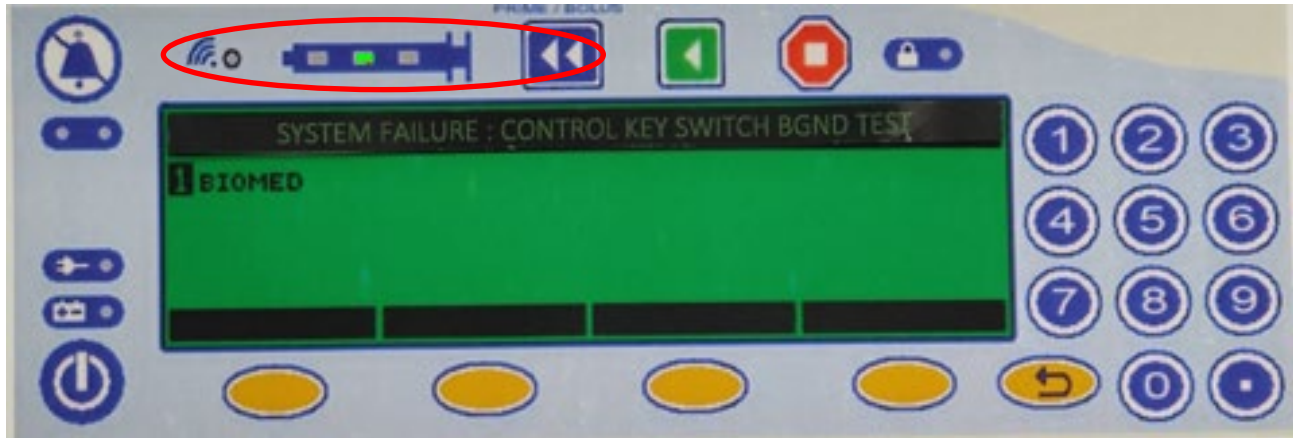
the pattern recycles. **If a System Failure alarm occurs during the small window of time when the pump is transitioning from IVOT delay to IVOT delivery, the pump may continue to run without the ability to terminate infusion via the Stop or Power keys.** In the following figure (Figure 2) , the green light indicates infusion is ongoing even though the pump displays a System Failure alarm.

Figure 2: Green light indicates IVOT Infusion Continues after System Failure

Failure of the pump to stop running in a System Failure condition could result in over-delivery of medication which could cause serious harm or death. **To date, Smiths Medical has received reports of one serious injury potentially related to this issue.**

1. **Do not use the IVOT delivery mode until this issue is fixed in a future software update.** Program each infusion separately instead of using the IVOT delivery mode program.

2. If an IVOT delivery mode program is inadvertently programmed and this issue occurs:
 - Immediately remove the syringe from the pump to stop the infusion, and press the Power button to turn the pump off.

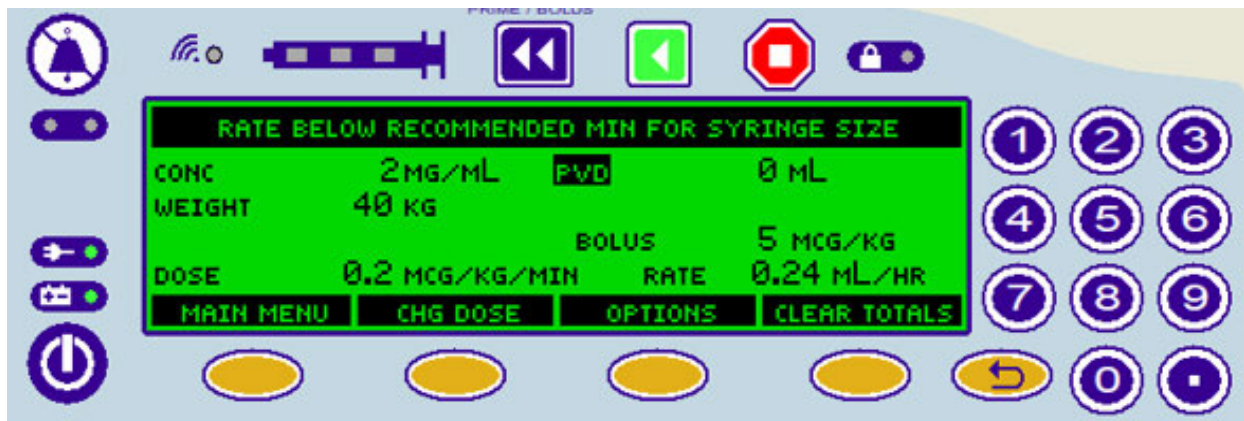
Under certain conditions, **the pump may use incorrect syringe parameters to determine if the programmed rate is below recommended minimum for the syringe size.** The pump will display a false “Rate Below Recommended Minimum for Syringe Size” alarm if this occurs, though the rate may be appropriate for the loaded syringe. The following figure (Figure 3) contains an example of this alarm screen.

When this occurs, the pump uses the Recommended Minimum Rate for the largest syringe of the same brand in the configuration for the Rate Below Recommended Minimum Rate check instead of the Recommended Minimum Rate for the syringe loaded into the pump. Although this issue does not directly impact delivery accuracy, and the pump will display the correct syringe brand and size, **this issue has the potential to affect fluid delivery since it may impact the rapid occlusion detection ability of the pump. “Pressure Increasing” alarms may occur earlier than expected or have false alarms, either with or without an occlusion present.**

Figure 3: False Rate Below Recommended Minimum for Syringe Size Alarm

The occurrence of a false “Rate Below Recommended Minimum for Syringe Size” alarm does not prevent programming or initiating an infusion but may lead to a delay in the initiation of therapy. This issue may cause “Pressure Increasing” alarms to occur earlier than expected or have false alarms, either with or without an occlusion present, which may inappropriately interrupt infusions. This may also cause therapy delays while the clinician addresses the issue and reprograms the infusion. To date, Smiths Medical has not received any reports of serious injuries or deaths related to this issue.

1. **If multiple syringes are needed for an infusion, program each syringe as a new infusion.**
2. If you see this false “Rate Below Recommended Minimum for Syringe Size” alarm notification, do not continue the infusion: clear the infusion and re-program the infusion with the desired infusion parameters and syringe.

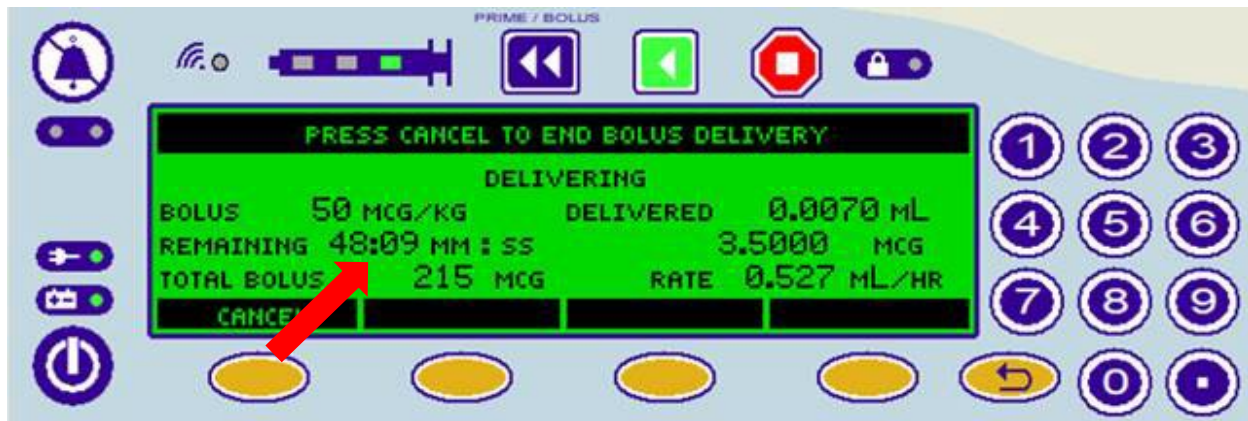
In rare situations, the pump may display an incorrect value for the time remaining during a **Bolus Dose or Loading Dose infusion** (see Figure 4). If this issue occurs, the **pump will infuse correctly to the intended infusion time even though the displayed time remaining is incorrect**. The pump appropriately transitions to continuous infusion upon completion of the Bolus Dose or Loading Dose as programmed.

Figure 4: Example of Incorrect Time Remaining. “REMAINING 48:09 MM:SS” should be displayed as “REMAINING 04:09 MM:SS”

Displaying incorrect or conflicting information to users could potentially result in the user interrupting the therapy due to confusion, which may also cause a delay in therapy. To date, Smiths Medical has not received any reports of serious injuries or deaths related to this issue.

- When programming and monitoring Bolus Dose and Loading Dose infusions, verify that the displayed time remaining on the screen is the same as the intended time.

- If the displayed time remaining is incorrect, your options include:**
 - Depending on the clinical scenario, including consideration of the patient condition and the medication, use your clinical judgement to determine if it is appropriate to continue the infusion with the incorrect remaining time displayed, while closely monitoring the Bolus or Loading Dose to verify that the infusion converts to the continuous infusion at the intended time.

- Program the intended Loading Dose or Bolus Dose as a separate intermittent infusion. When the infusion completes, program the continuous infusion.
 - Be aware that the issue will recur if the pump (or a replacement pump) is programmed with the same Bolus Dose / Loading Dose, and continuous infusion.
