URGENT FIELD SAFETY NOTICE

Revaclear 400 Dialyzer, Revaclear 300 dialyzer

FA-2022-054

Safety Alert

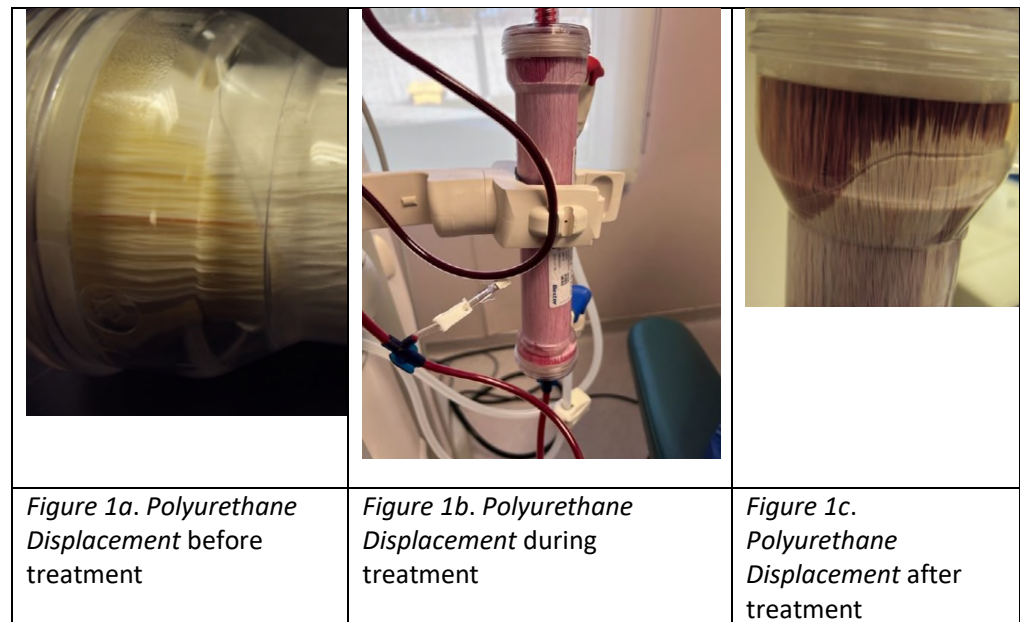
Figure 1

Baxter Healthcare Corporation has identified that certain lots of Revaclear 300 dialyzers and Revaclear 400 dialyzers (listed below) may be impacted by *Polyurethane Displacement* on the fibers at or near the two opposite ends of the dialyzer, i.e., near the header cap and on the opposite side of the dialysate (Hansen) port. This issue causes the fibers in the dialyzer to appear translucent prior to use, which therefore causes the fibers to visually appear more red during treatment even though proper blood flow is occurring through the fibers.

The *Polyurethane Displacement* issue may be mistakenly identified as an *Internal Blood Leak*. *Polyurethane Displacement* does not necessarily mean that an *Internal Blood Leak* is present. Although there are some similarities with the manner in which *Polyurethane Displacement* and an *Internal Blood Leak* may visually appear, these are distinguishable events and only an actual *Internal Blood Leak* will trigger a blood leak alarm.

Typical examples of a dialyzer with *Polyurethane Displacement* are shown below in *Figure 1*. After dialysis therapy has commenced, the *Polyurethane Displacement* will characteristically appear bright red and the affected fibers will be in a concentrated area at either end of the dialyzer, located opposite the dialysate connector.

Displacement of the polyurethane may mistakenly be identified as an internal blood leak. This could prompt the operator to stop therapy and discard the extracorporeal circuit unnecessarily, leading to blood loss equivalent to the extracorporeal circuit volume and delay in therapy. There have been no reports of serious injury related to this issue.

1. Be aware of the difference in appearances between *Polyurethane Displacement* and an *Internal Blood Leak*, and ensure your staff is also aware.
2. If you receive a blood leak alarm, follow your clinical practice to stop the treatment and report the issue to Baxter.
3. If you only observe *Polyurethane Displacement* and there is no blood leak alarm on the machine, you may continue to use the dialyzer.
