Urgent Field Safety Notice

MiniMed™ 780G insulin pump

Pump Errors After Quick Bolus - Software Update

Medtronic reference: FA963

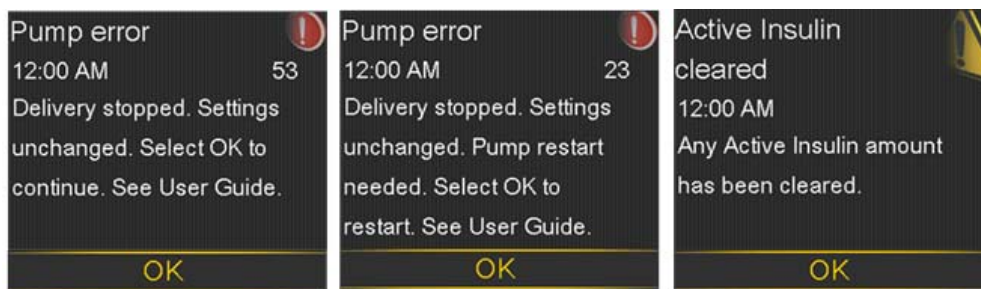
If all the above conditions are met, within 2 minutes of bolus delivery completion, the pump initiates Pump error 53, followed by Pump error 23 alarm. The following screens are presented in the pump screen:

Upon clearing the pump errors, the pump resets and indicates Active Insulin has been cleared. The pump then guides the user to resume operation in Manual Mode. The SmartGuard™ status screen indicates the warm-up period has started. After approximately 5 hours, the SmartGuard™ feature will be available.

Since Active Insulin will display 0.0 units in the pump after experiencing the pump errors above, if the user is not aware of the amount of active insulin and delivers an additional bolus, there is a risk of insulin over delivery, which may result in low blood sugar (hypoglycemia) or severe hypoglycemia. In rare cases, severe hypoglycemia, if left untreated, may lead to a life-threatening situation.

Upgrade your MiniMed™ 780G insulin pump software to version 6.7 using one of the three options below:

If you need to deliver large boluses (17.1U) at quick speed using your pump, it is best to replace your MiniMed™ 780G insulin pump with a pump with software version 6.7 now. To do so, please contact the Diabetes Hotline at Tel.Nr. 0800/6464633.
