# Urgent Field Safety Notice Product Correction

**Date Issued** July 28, 2009

Product Name	List Number	Part Number
ARCHITECT i2000 System	8C89 1G17	
ARCHITECT i2000SR System	3M74	
Concentrated Wash Buffer (1 L)	6C54-58	
Concentrated Wash Buffer (10 L)	6C54-88	
Wash Zone Mechanism Grounding Kit		7-201369-01

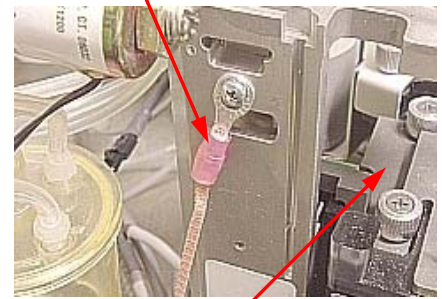
**Ground strap (cable)**

Based on a single customer report and our internal investigation, we have determined that under specific conditions (such as spills, leaks, or improper maintenance) on the ARCHITECT i2000 or i2000SR Systems, the concentrated wash buffer (containing sodium azide) can come in contact with the wash zone mechanism ground straps (cables) on either of the two wash zones. The copper in the ground strap may corrode and form an unstable chemical substance (metal azide) that may be sensitive to direct pressure and impact.

Ground straps that are covered with residual solids and/or show other signs of chemical effects may react to impact or other pressure, possibly resulting in a popping noise and release of particulates from the cables. Please follow your laboratory procedures related to use of personal protective equipment (safety glasses, lab coat, gloves, etc.).

When performing weekly maintenance procedure 6015 WZ Probe Cleaning – Manual, observe the condition of the ground strap. If there is corrosion on the cable, **DO NOT TOUCH IT**. Contact Abbott immediately.
