## Urgent Field Safety Notice

### VITROS<sup>®</sup> 5600 Integrated System Software Version 1.4 and below VITROS<sup>®</sup> 3600 Immunodiagnostic System Software Version 1.4 and below MicroWell and/or MicroTip Reagent Management

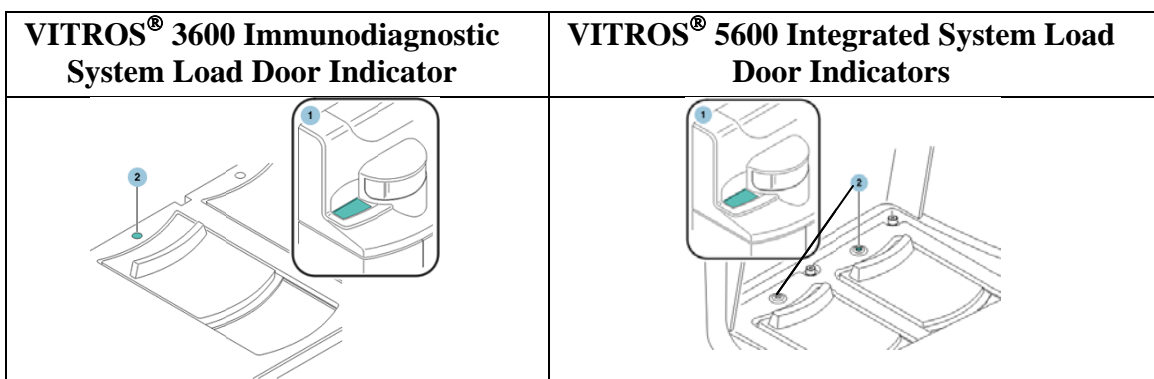
Reagent Packs may be misidentified when the Reagent Supply load door<sup>1</sup> is opened before the green LED indicator lights<sup>2</sup> for the MicroTip and/or Microwell Reagent Supplies.

1. The MicroWell and/or MicroTip Reagent Supply load door is opened before the green LED Indicator lights, and while a reagent supply scan is occurring, **and**
2. The Reagent Supply Ring is manually moved so that the position that was just scanned is moved to the load door position, **and**
3. The MicroWell or MicroTip Reagent Pack in the load door position is removed and another pack is loaded in the same position.

As a result of these events, one Reagent Pack in the affected Reagent Supply could be misidentified if the second reagent pack loaded is different from the original reagent pack that was scanned. To prevent this occurrence, do not open the reagent supply load door until the green LED indicator lights (as per V-Docs procedures). This indicates the Reagent Supply Ring is in position for loading.

- If a system initialization fails, wait at **least 15 seconds** after the “Not Ready” message is displayed before touching the Initialize button on the Condition Review screen.
- Before loading reagent packs, wait for the Reagent Supply green LED Indicator on the load door to light prior to opening the Reagent Supply Load door.
- Display this communication near the system to ensure compliance by all operators of the VITROS<sup>®</sup> 5600 Integrated System or VITROS<sup>®</sup> 3600 Immunodiagnostic System.
- Complete and return the attached Confirmation of Receipt Form by August **XX**, 2010.
- Forward this information if you have distributed this product outside of your facility.
