**FIELD SAFETY NOTICE**  
**ACL TOP FAMILY: ACL TOP, ACL TOP CTS, ACL TOP 700, ACL TOP 700 CTS, ACL TOP 700 LAS, ACL TOP 500 CTS AND ACL TOP 300 CTS**

June 2014

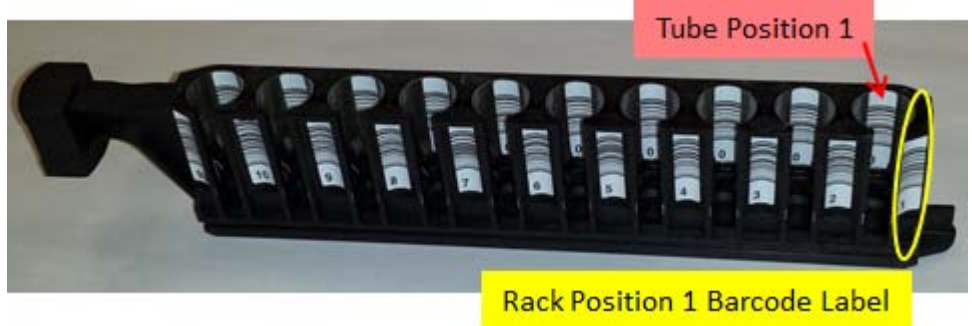
1. A sample rack containing a barcoded sample in Tube Position 1 (Sample A) is positively identified by the instrument when inserted in any instrument sample area track position.

2. If, during removal of this sample rack containing Sample A, the Rack Position 1 Barcode Label (see picture above) is not recognized by the instrument (the instrument does not alert the user of the error); and,
3. A sample rack is inserted into the same instrument sample area track position before the barcode reader is moved by the user or automatically by the instrument; and,
4. The new rack or re-inserted sample rack contains a different barcoded sample (Sample B) in Tube Position 1; and,
5. Finally, the Rack Position 1 Barcode Label is also not recognized by the instrument, then Sample B will be misidentified as Sample A.

Under the above conditions, the sample ID from Sample A will be misassigned to Sample B.

1. After removing a sample rack, insert the next sample rack in a different available instrument track position.
2. If there are no available track positions, home the barcode reader before inserting the next sample rack by selecting the “Home Barcode Reader”
