Ortho Clinical Diagnostics	<p style="color: red; margin: 0;">URGENT FIELD SAFETY NOTICE</p> <p style="margin: 0;">Potential Sample Metering Anomaly on VITROS® Systems using Software Version 3.2.2 and Below</p> <p style="color: red; margin: 0;">Immediate Action Required</p>
----------------------------	---

Date April x, 2016

Affected Products

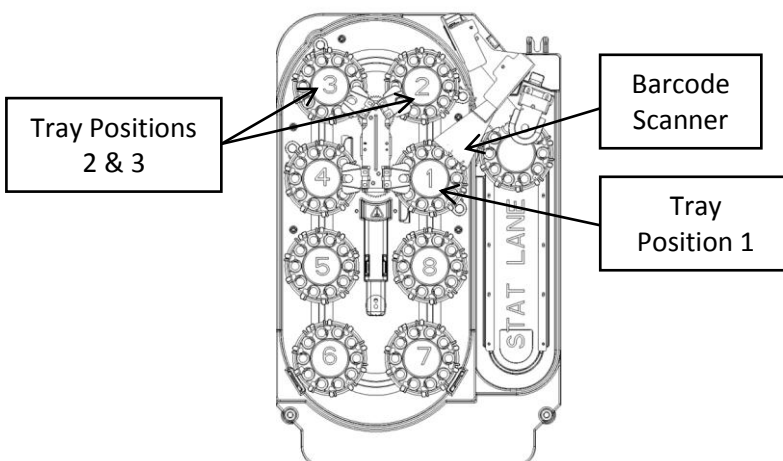
4. How can I determine tray positions in the Sample Supply?

Located within the Sample Supply, there are 4 sampling positions in the Routine Lane. The following *specific* sequence of events must occur in order for the software timing anomaly to happen:

The affected positions located in the Routine Lane of the Sample Supply as shown below:
