**URGENT FIELD SAFETY NOTICE****Potential for Unsuppressed Results using VITROS® 5600 Integrated Systems**

Name	Product Code (Unique Identifier)	Software Versions
VITROS® 5600 Integrated System	6802413 (10758750002740)	3.3.1 and Below
VITROS® 5600 Integrated System Refurbished	6802915 (10758750007110)

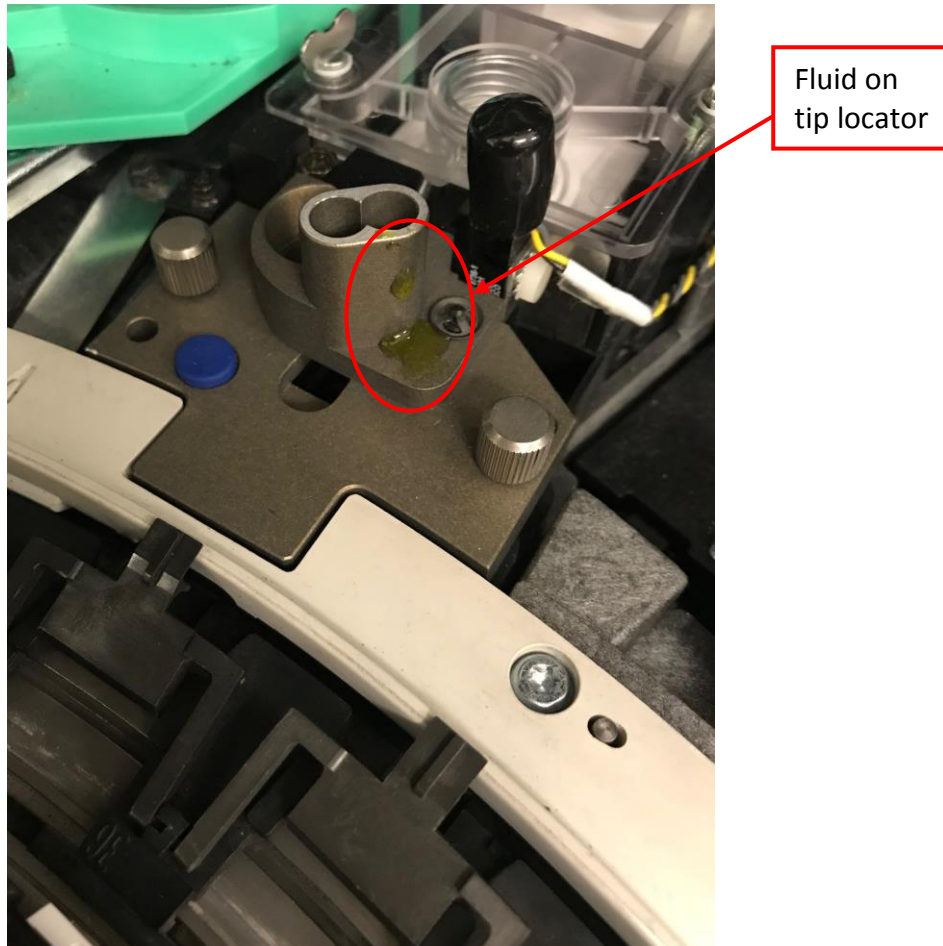
If these specific circumstances occur, the proboscis may deposit fluid on the tip locator or top surface of the slide and transfer sample fluid into the incubator.

2. How can I determine if sample fluid is present on the VITROS 5600 Tip Locator?

The photograph below shows an example of fluid on the tip locator:

- If you observe unexpected MicroSlide assay results for a sample associated with TE1-504 and/or TE1-594 condition codes, please do the following:
 - Inspect the tip locator to determine if sample fluid is present. Refer to example shown on page three.
 - If fluid is NOT observed, repeat all MicroSlide assays for the affected sample.
 - If sample fluid is observed on the tip locator or repeated results do not agree (i.e., incorrect results), contact the Ortho Care™ Technical Solutions Center for further assistance.
- Complete the Confirmation of Receipt form no later than **August xx, 2018**.
- Post this notification by each VITROS 5600 System in your facility or with the user documentation.
