## Aptio® Automation StreamLAB® Automation

### Some modules missing pacemaker warning labels

## Reason for Correction

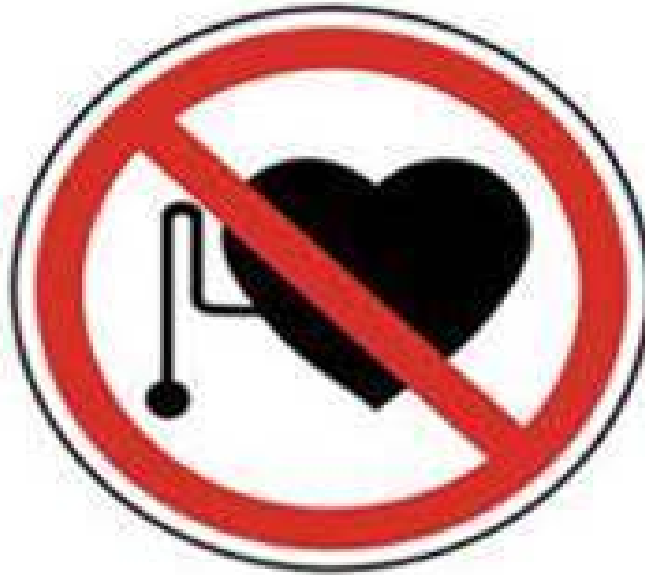
- In the modules listed in Table 1 and 2, the transport mechanism that moves the robot along the axes, generates a magnetic field which may interfere with pacemaker functionality at close distances.
- The pacemaker safety label shown below indicates the potential risk of interference to pacemaker functionality. On some modules, this label may be missing.

Tape this sheet to any module listed in Table 1 or Table 2 that is missing a warning label:

1. Personnel fitted with a pacemaker must not be at distances less than 200 mm (7.87 inches) of the modules axes (transport mechanisms) for the modules listed in Table 1 and Table 2 even if the warning label is missing.
2. Verify that the modules listed in Table 1 and 2 all have a pacemaker safety label attached either on the cover or inside the cover of the module. If there is no safety label on the module,

please remove the last page of this letter and tape a copy of the safety label to the cover of the module until an official Siemens product label is available.
