## **URGENT FIELD SAFETY NOTICE**

Our Ref: 4215 FSCA

**VITEK® 2 Identification (ID) / Antimicrobial Susceptibility Test (AST) Cards referenced in Appendix A.**

FSCA 4215 : VITEK<sup>®</sup> 2 – Card Pouch Integrity

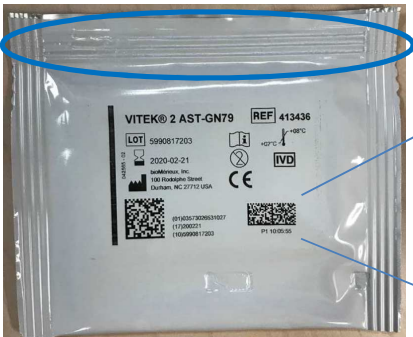
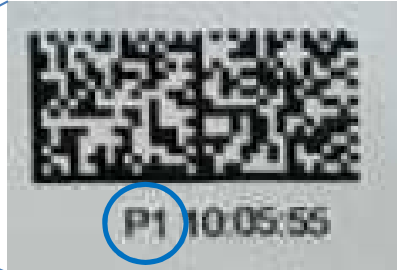
**Figure 1: Top Seal and Pouch ID**

A potential issue was identified related to the top seal of card pouches containing the VITEK® 2 test cards for the product lots specified in Appendix A. bioMérieux has determined that the integrity of some of the VITEK® 2 test card top seal may be compromised (see Figure 1). Based on our investigation, a compromised test card top seal can impact card reagents due to the entry of moisture.

bioMérieux investigation concluded that the pouch top seal of the card lots manufactured on a specific card poucher (Pouch 1) between 10Aug2018 and 29Aug2018 is potentially compromised. A small section of the top seal may be improperly sealed for the card lots indicated in Appendix A.

1. As VITEK® 2 ID/AST cards may be pouched on different pouching equipment in manufacturing, confirm the card was pouched on Pouching P1 and determine if a P1 indication is present (Figure 1). Cards that have other identifiers, such as P2, P3, etc. are not impacted.
2. Grasp the card pouch so the top seam is facing you.
3. Apply a modest pulling force to each side of the top edge of the pouch, at three (3) separate points as shown in the images below.
